**WATERSHED
MANAGEMENT PLAN
FOR THE BOLONGO
BAY WATERSHED
ST. THOMAS, USVI**

JUNE 2022

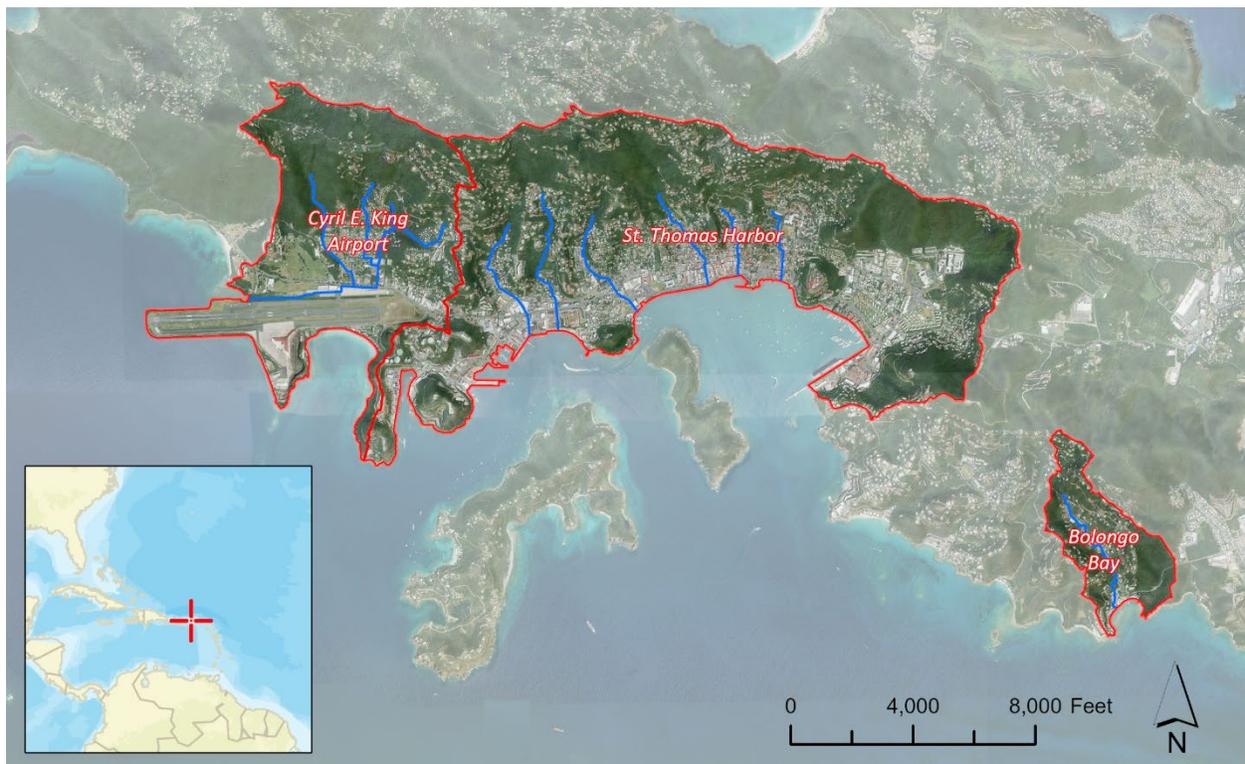
Figure 1. The three study watersheds on St. Thomas are outlined in red.

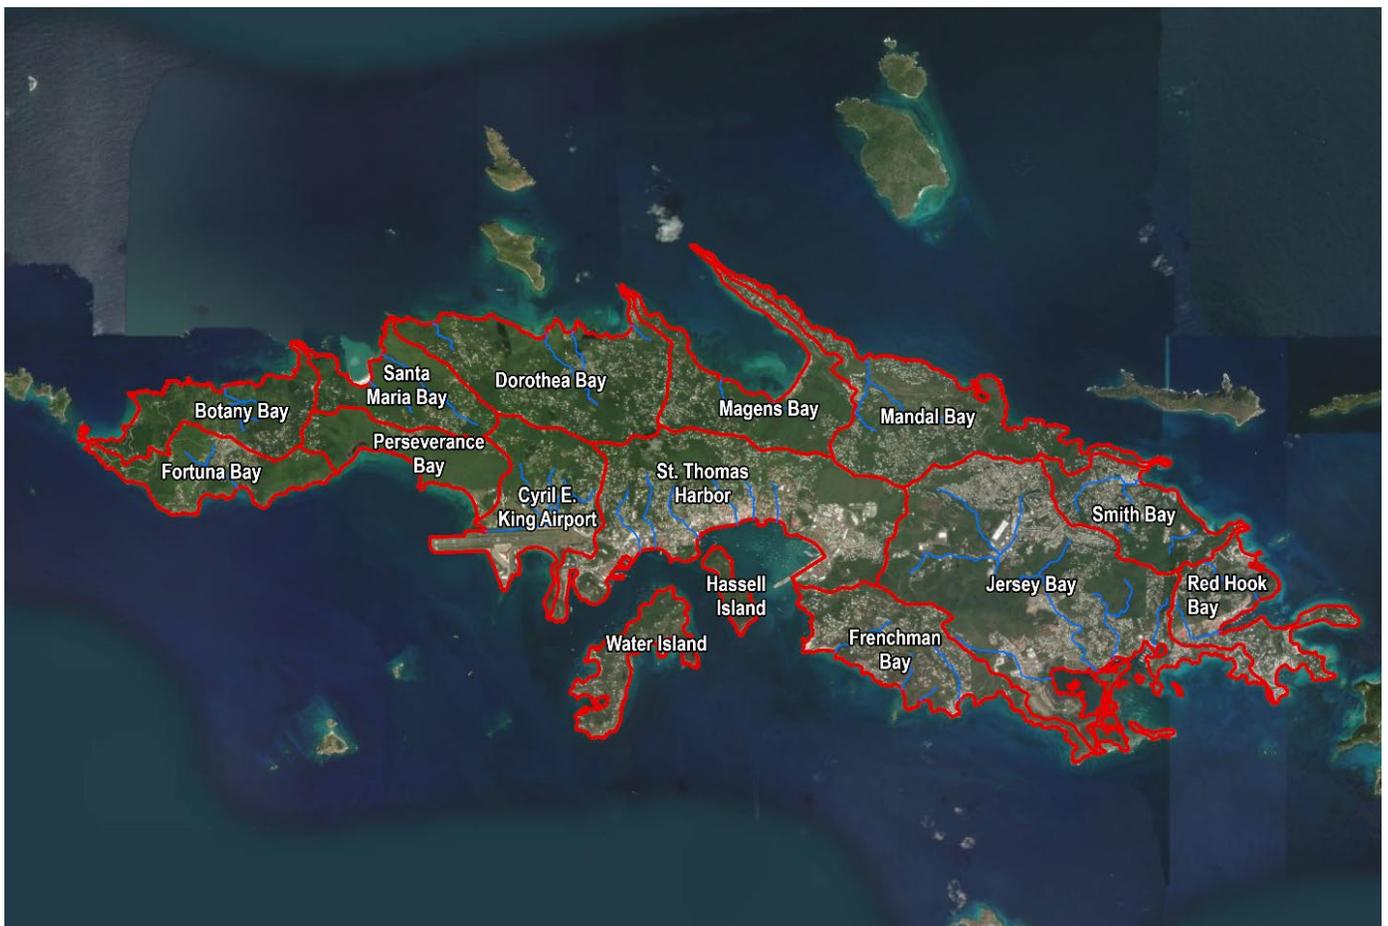
Figure 4. Watersheds of St. Thomas.

A watershed is an area of land where rainfall drains to a common body of water such as a bay or harbor. There are 15 primary watersheds on St. Thomas, separated from each other by the crests of hills, ridgelines, and constructed infrastructure that guide the movement of water across the land (Figure 4). Each of these watersheds is made up of smaller drainage systems called subwatersheds that are also determined by topography and water flow.

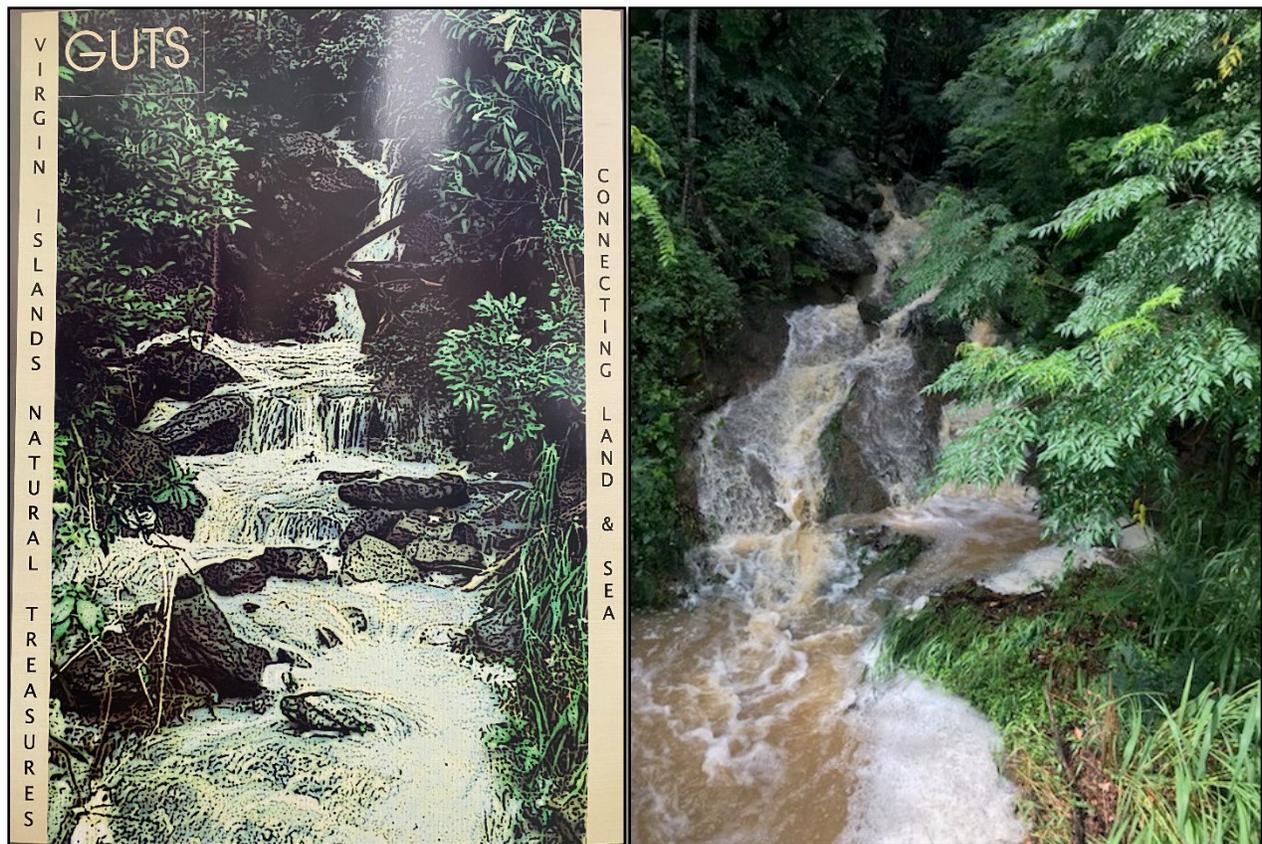
Figure 6. Illustration of a gut by the University of the Virgin Islands, Cooperative Extension Service (left) and picture of gut (right).

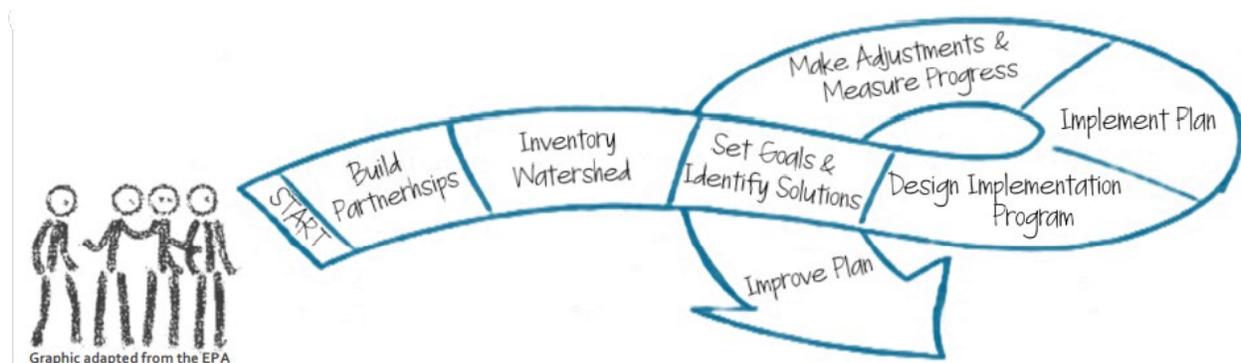
Figure 7. Conceptual drawing of the WMP and implementation process.

In developing this WMP, the guidelines established in the U.S. Environmental Protection Agency's (EPA) *Handbook for Developing Watershed Plans to Restore and Protect our Waters* (the Handbook) were followed (U.S. EPA, 2008). The Handbook details a six-step process for watershed planning as outlined in Figure 7. The contents of this WMP are the product of Steps 1-4, that is, build partnerships (Step 1), characterize watersheds (Step 2), set goals and identify solutions (Step 3), and design an implementation program (Step 4). Recommendations for implementation of the WMP (Step 5) and measurement of progress and making adjustments as progress is made (Step 6) are also provided within this WMP. It is important to note that the process of watershed management is dynamic and iterative. As more information is collected and lessons are learned, the implementation program should be reassessed, refined, and modified accordingly.

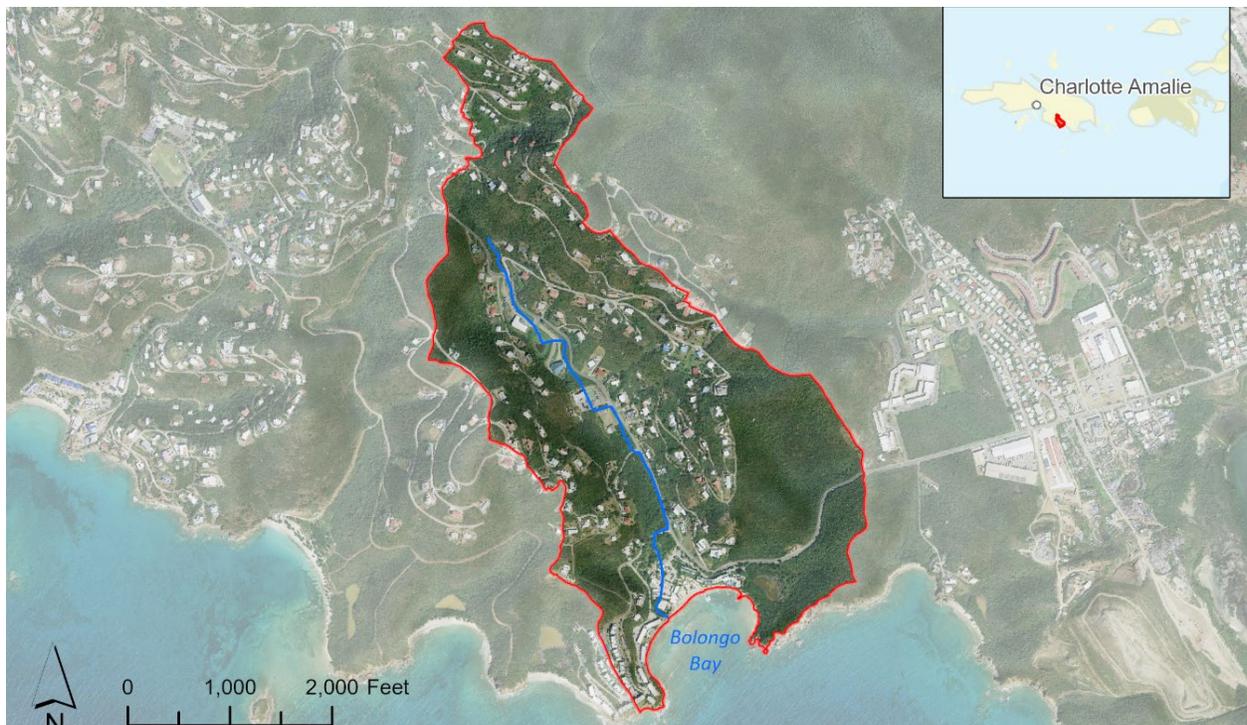
Figure 19. Overview map of the watershed.

Located in southeastern St. Thomas, the Bolongo Bay watershed encompasses 269 acres (Figure 19). The watershed population is 785, a majority of which are minorities based on 2010 US Census data. The watershed contains 0.9 miles of guts and 0.6 miles of shoreline. It includes 2.7 acres of wetlands, of which 74% are classified as riverine and the remaining are classified as estuarine and marine. Soils generally have a slow rate of infiltration and a high runoff potential. The total impervious cover of the watershed is approximately 18%, and the watershed has a high tree canopy cover of 65%. The primary zoning category is low-density residential (93.2%). Housing development in the watershed primarily occurred during the 1980s. Data from the U.S. Virgin Islands Department of Planning and Natural Resources (DPNR) ambient and beach water quality monitoring programs categorizes all assessment units as Class B with impairments for phosphorus, dissolved oxygen, enterococcus, and turbidity. See Appendix B-1 for the complete watershed characterization.

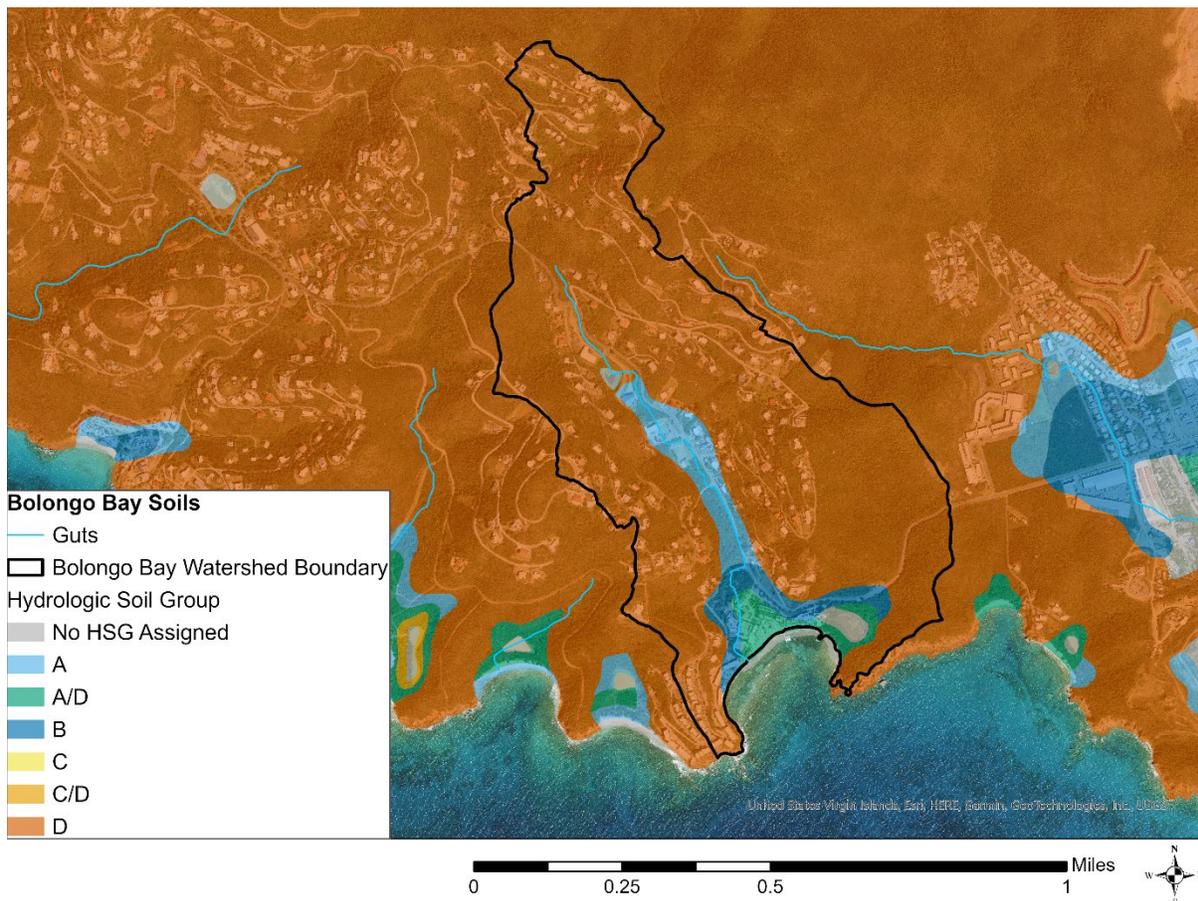
Figure 20. Hydrologic Soil Groups (HSG) in the watershed.

Figure 20 shows the distribution of HSG classes within the Bolongo Bay watershed and Table 4 provides a breakdown of the acres and percentages. The watershed consists predominantly of low infiltration soils,

Hydrologic Soil Group (HSG)	Area in Watershed (acres)	Percentage of Total Area (%)
A	13.9	5.2%
B	10.3	3.8%
C	0.0	0.0%
D	235.3	87.4%
A/D	6.8	2.5%
C/D	0.0	0.0%
No HSG Assigned	2.7	1.0%
<i>Total</i>	<i>269.1</i>	<i>99.9%</i>

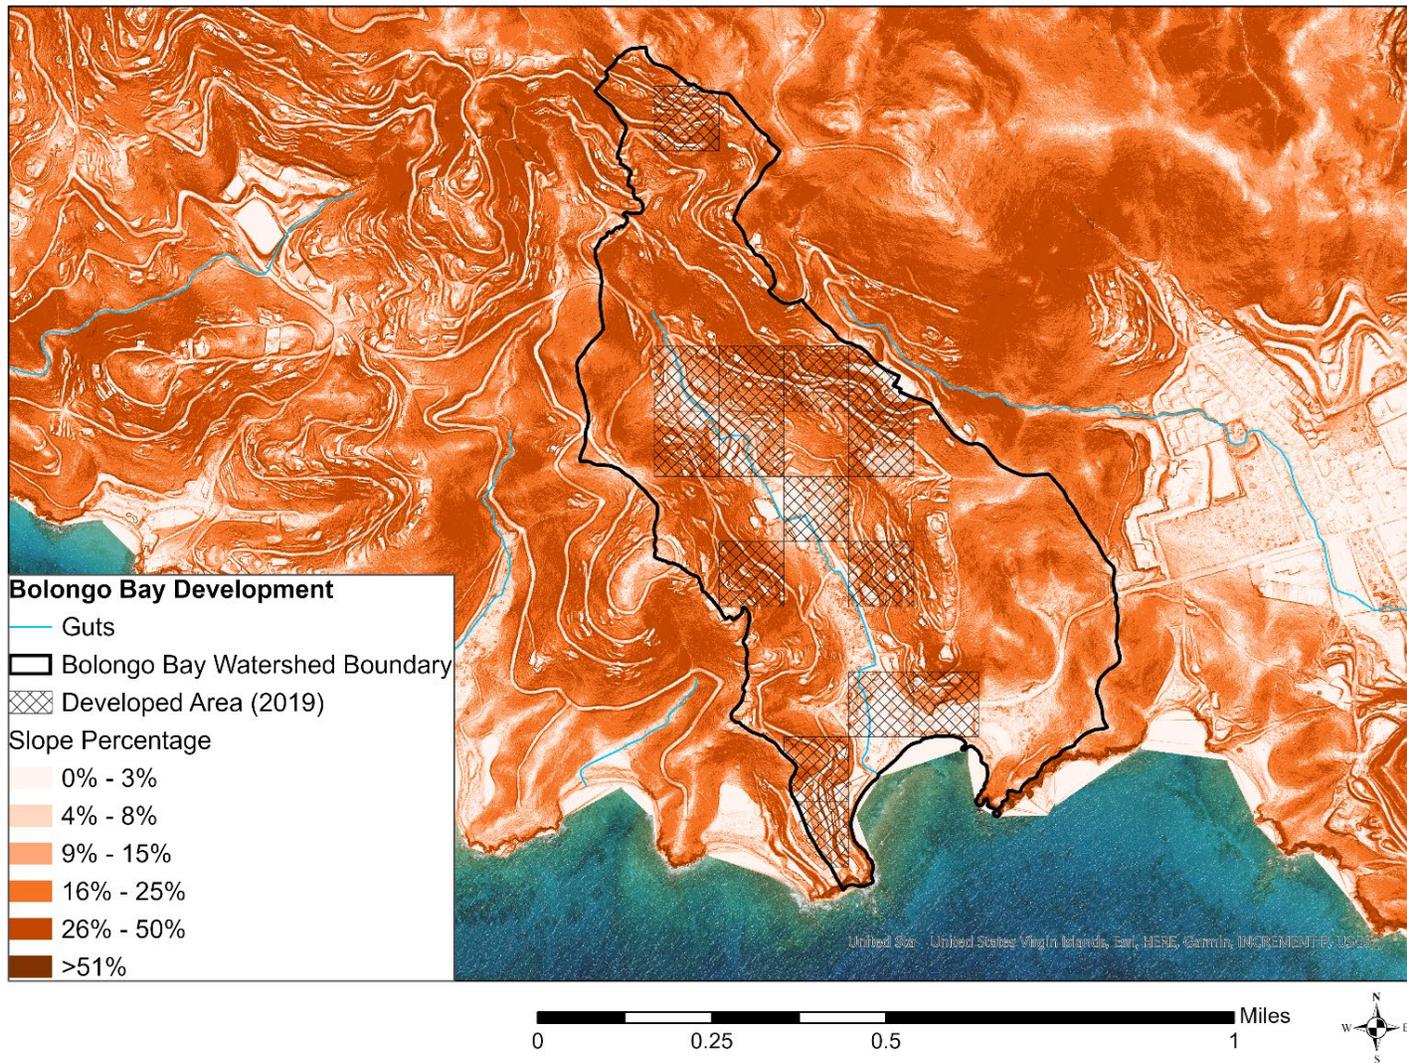
Figure 21 . Developed areas and slope percentages in the Bolongo Bay watershed.

Slope Percentage	Area in Bolongo Bay Watershed (acres)	Percentage of Total Area (%)
0% – 3%	29.1	10.8%
4% – 8%	34.1	12.7%
9% – 15%	47.2	17.5%
16% – 25%	80.0	29.7%
26% – 50%	74.3	27.6%
> 51%	4.5	1.7%
<i>Total</i>	269.2	100%

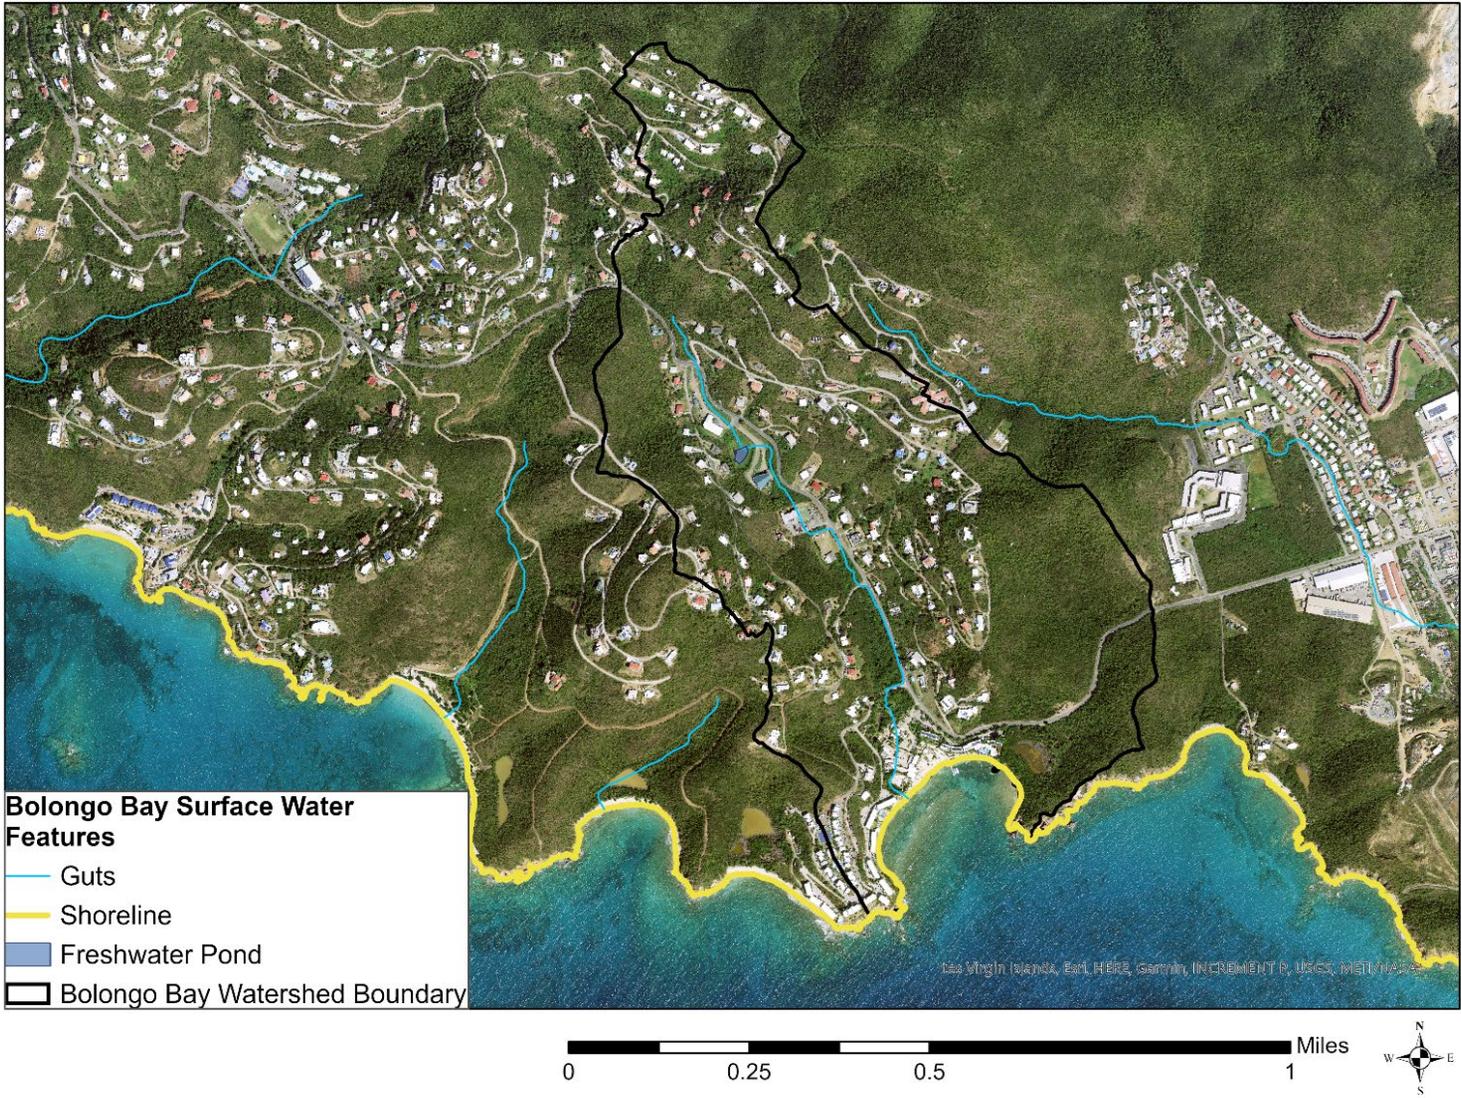
Figure 22. Surface water features in the Bolongo Bay watershed.

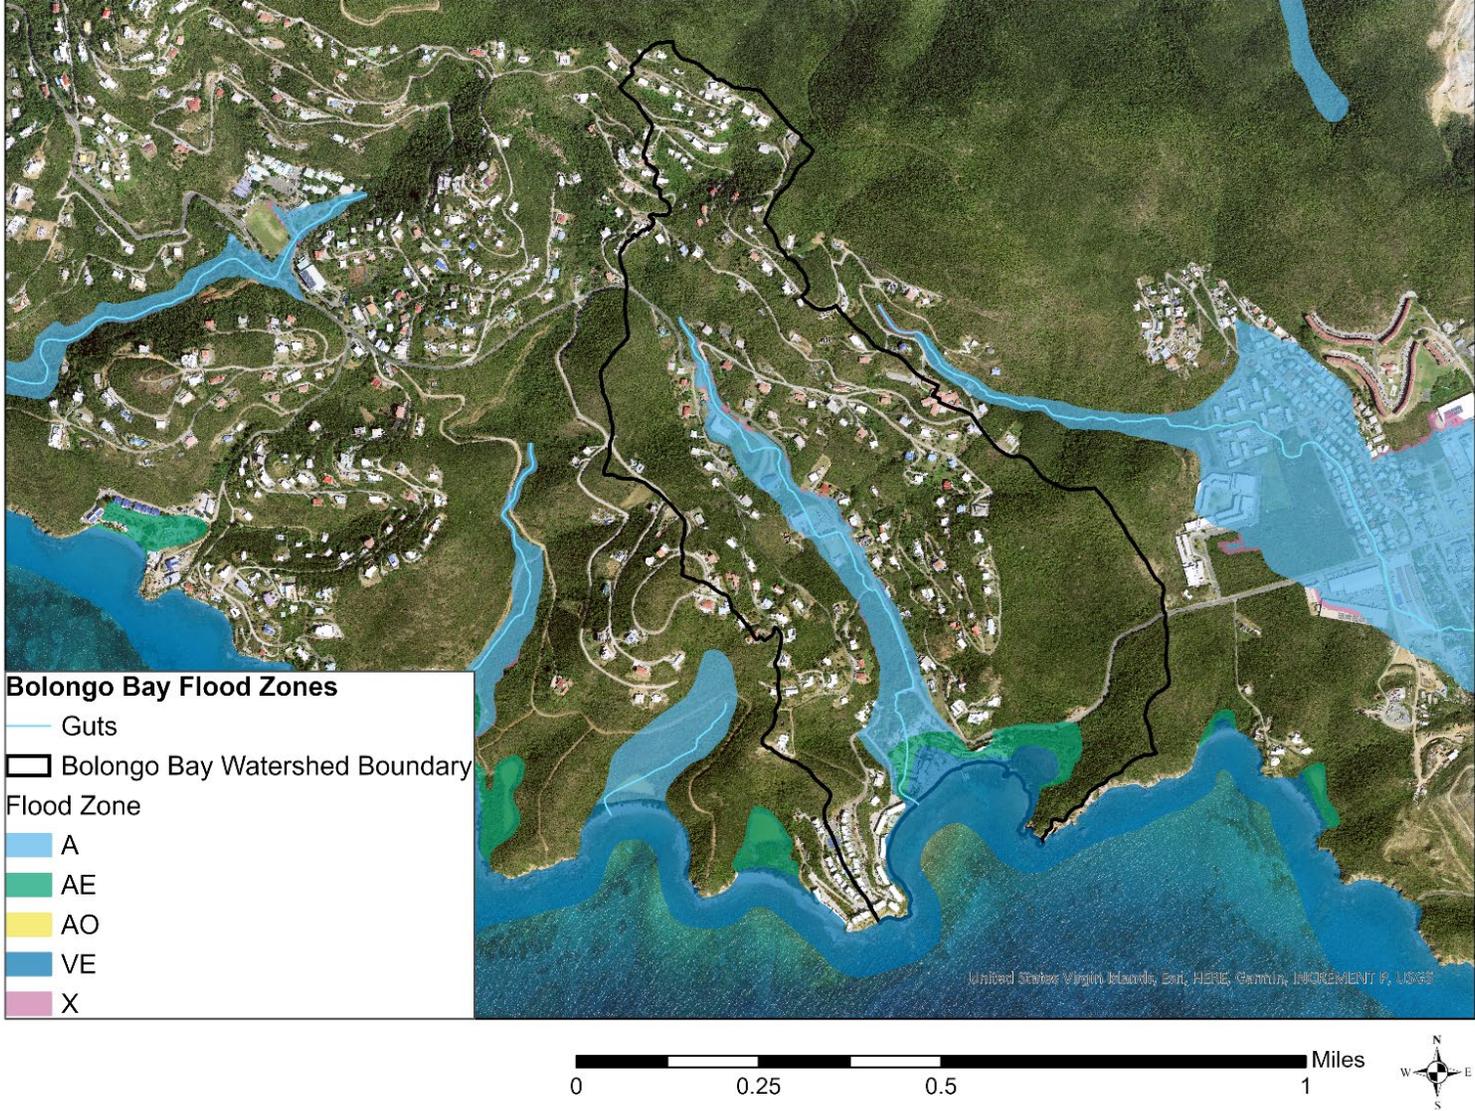
Figure 26. Flood zones in the Bolongo Bay watershed.

Flood Zone	Definition*	Area in Watershed (acres)
A	Areas subject to inundation by the 1-percent-annual-chance (100-year) flood event where no hydraulic analyses have been performed.	19.6
AE	Areas subject to inundation by the 1-percent-annual-chance (100-year) flood event where hydraulic analyses have been performed.	6.2
AO	Areas subject to inundation by the 1-percent-annual-chance (100-year) shallow flooding where average depths are between one and three feet.	0.0
VE	Areas subject to inundation by the 1-percent-annual-chance (100-year) food event with additional hazards due to storm-induced velocity wave action.	5.3
X	An area of minimal to moderate flood hazard that is outside of the Special Flood Hazard Area and either 1) between the limits of the base flood and the 0.2-percent-annual chance (500-year) flood, or 2) above the elevation of the 0.2-percent-annual-chance (or 500-year) flood.	0.7
*Definitions adapted from https://floodpartners.com/flood-zones/		Total: 31.7

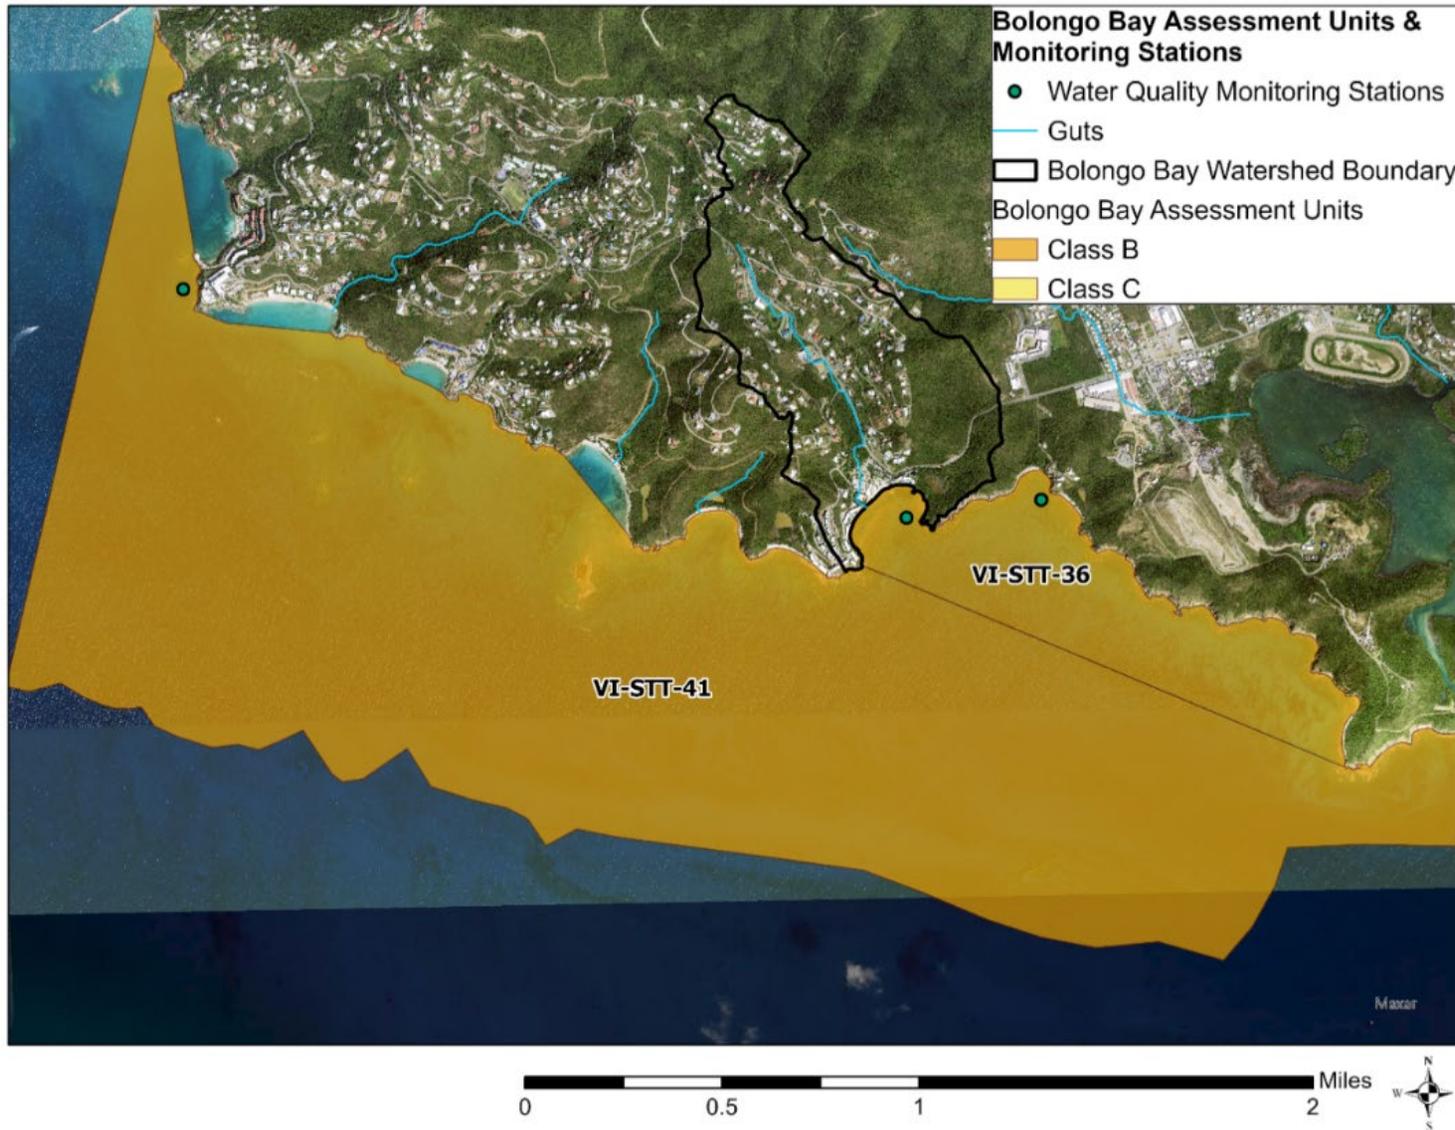
Figure 35. Assessment units and water quality monitoring stations in the watershed.

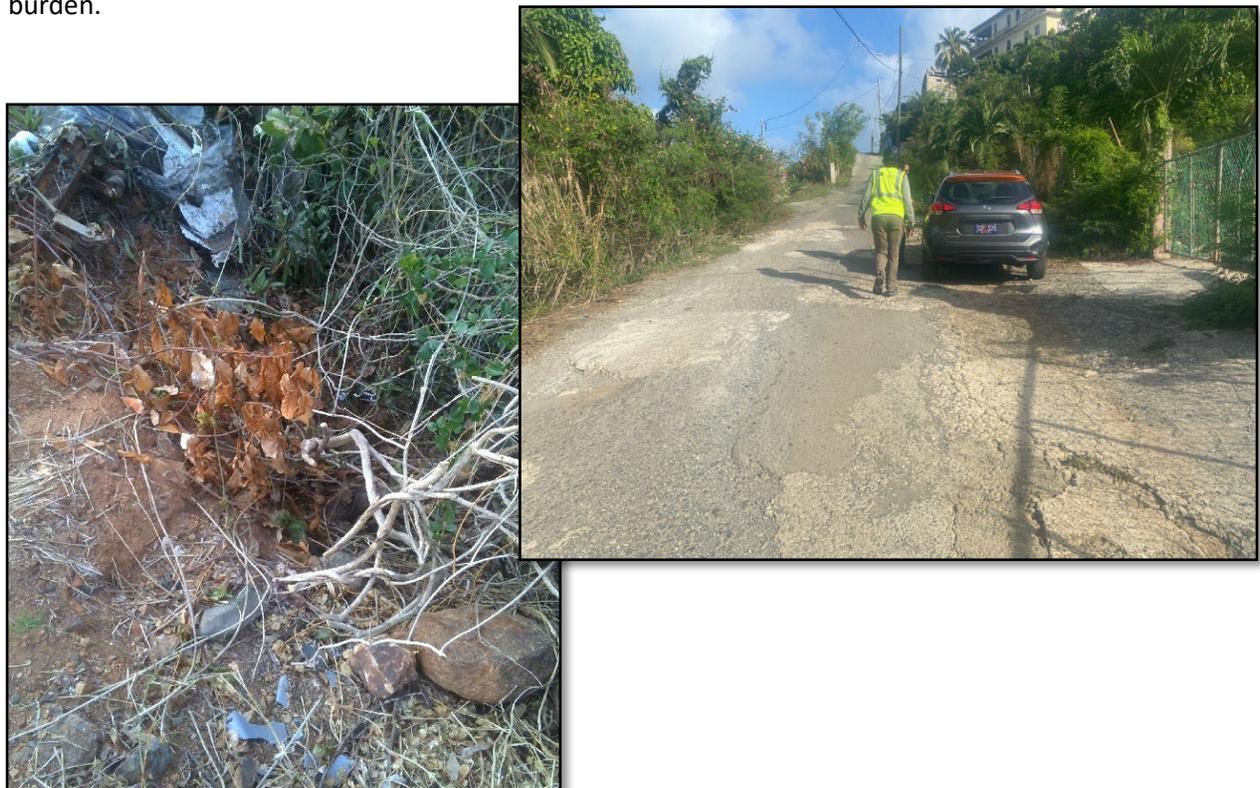
Figure 36. Culvert inlet plugged by sediment (left) and roadway erosion (right).

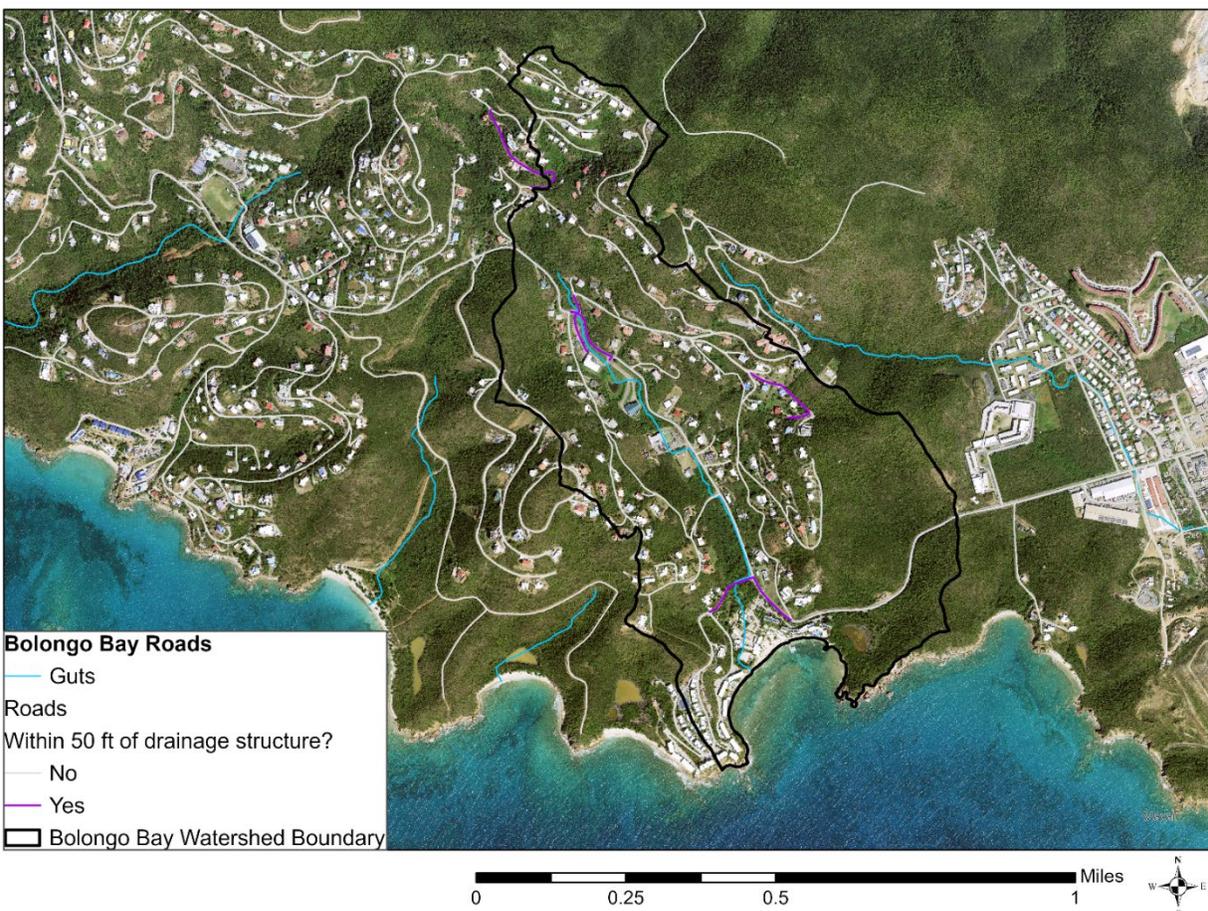
Figure 37. Roads in the watershed and a classification of distance to nearest drainage structure.

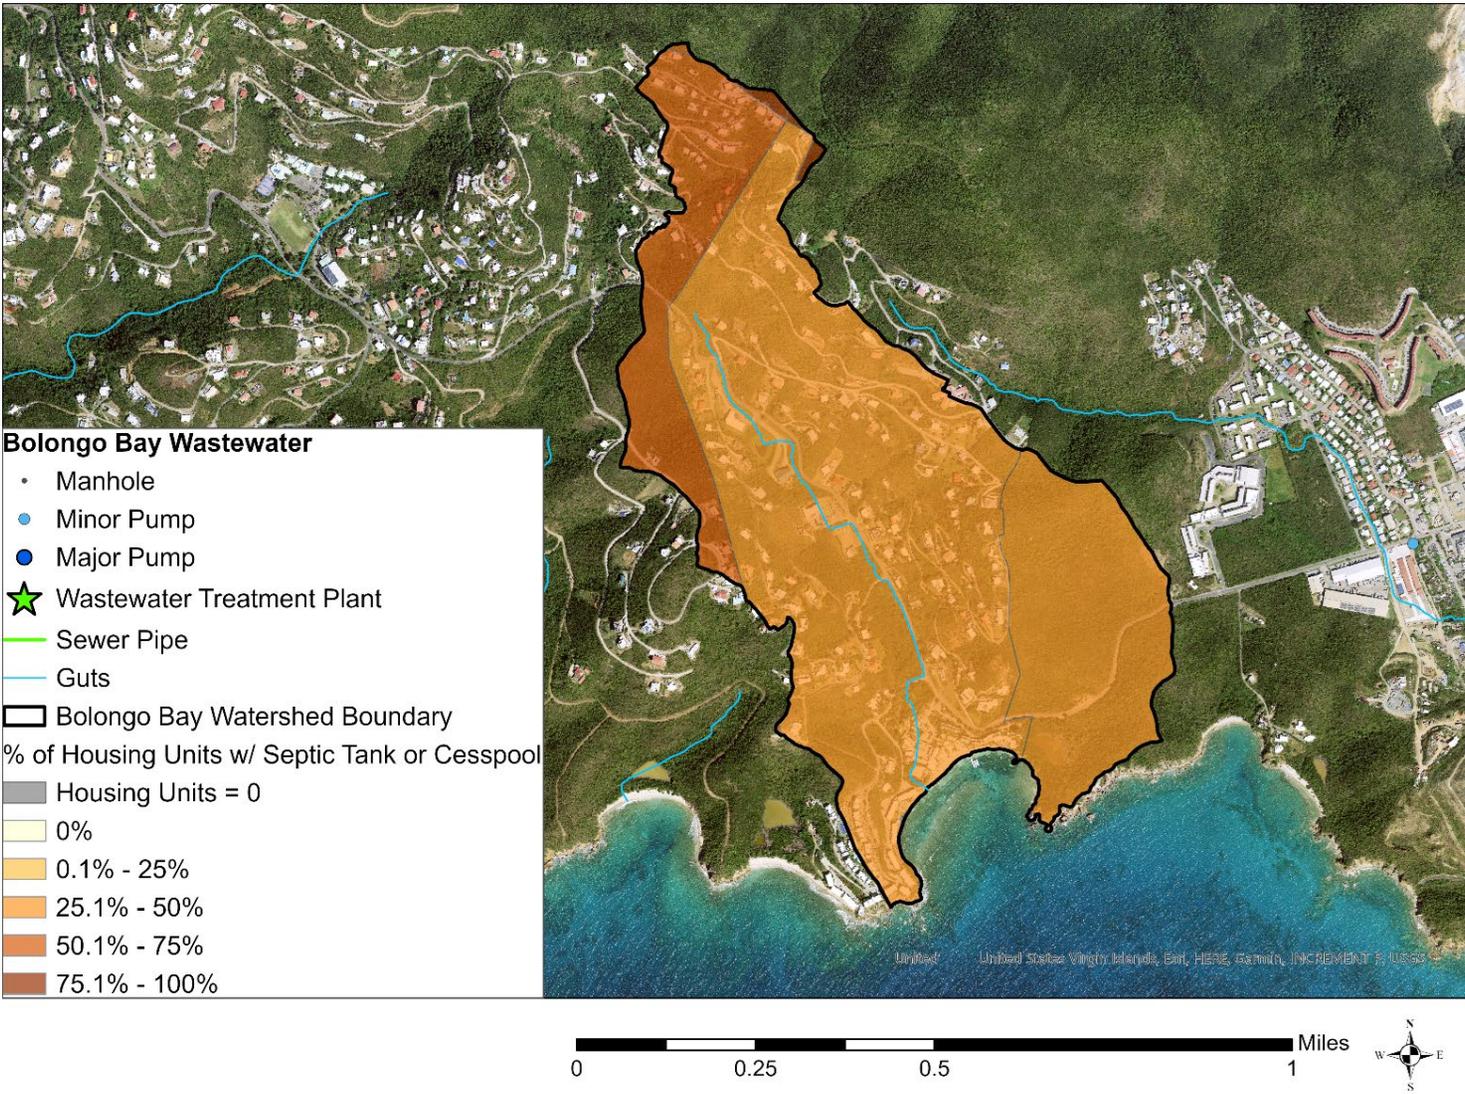
Figure 38. Sanitary sewer system and percent of housing units by estate with septic tanks or cesspools in the Bolongo Bay watershed (Sources: 2010 U.S. Census data, VIWMA).

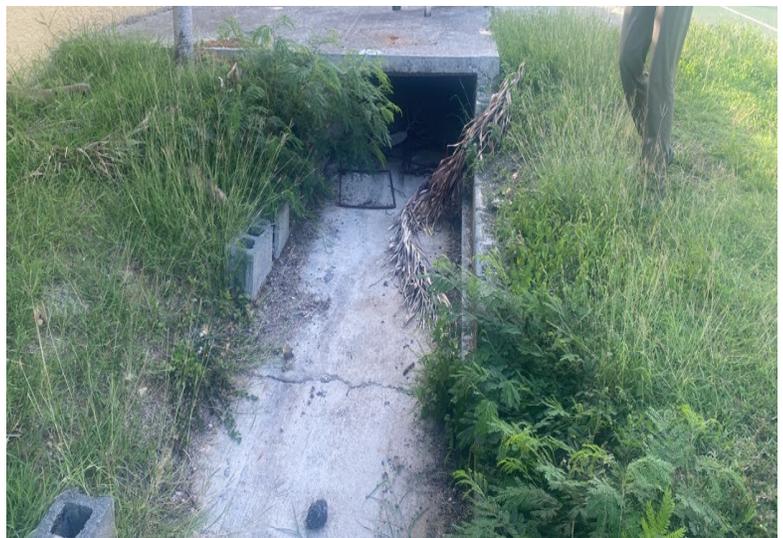
Figure 44. Example of a concrete swale identified during mapping phase.

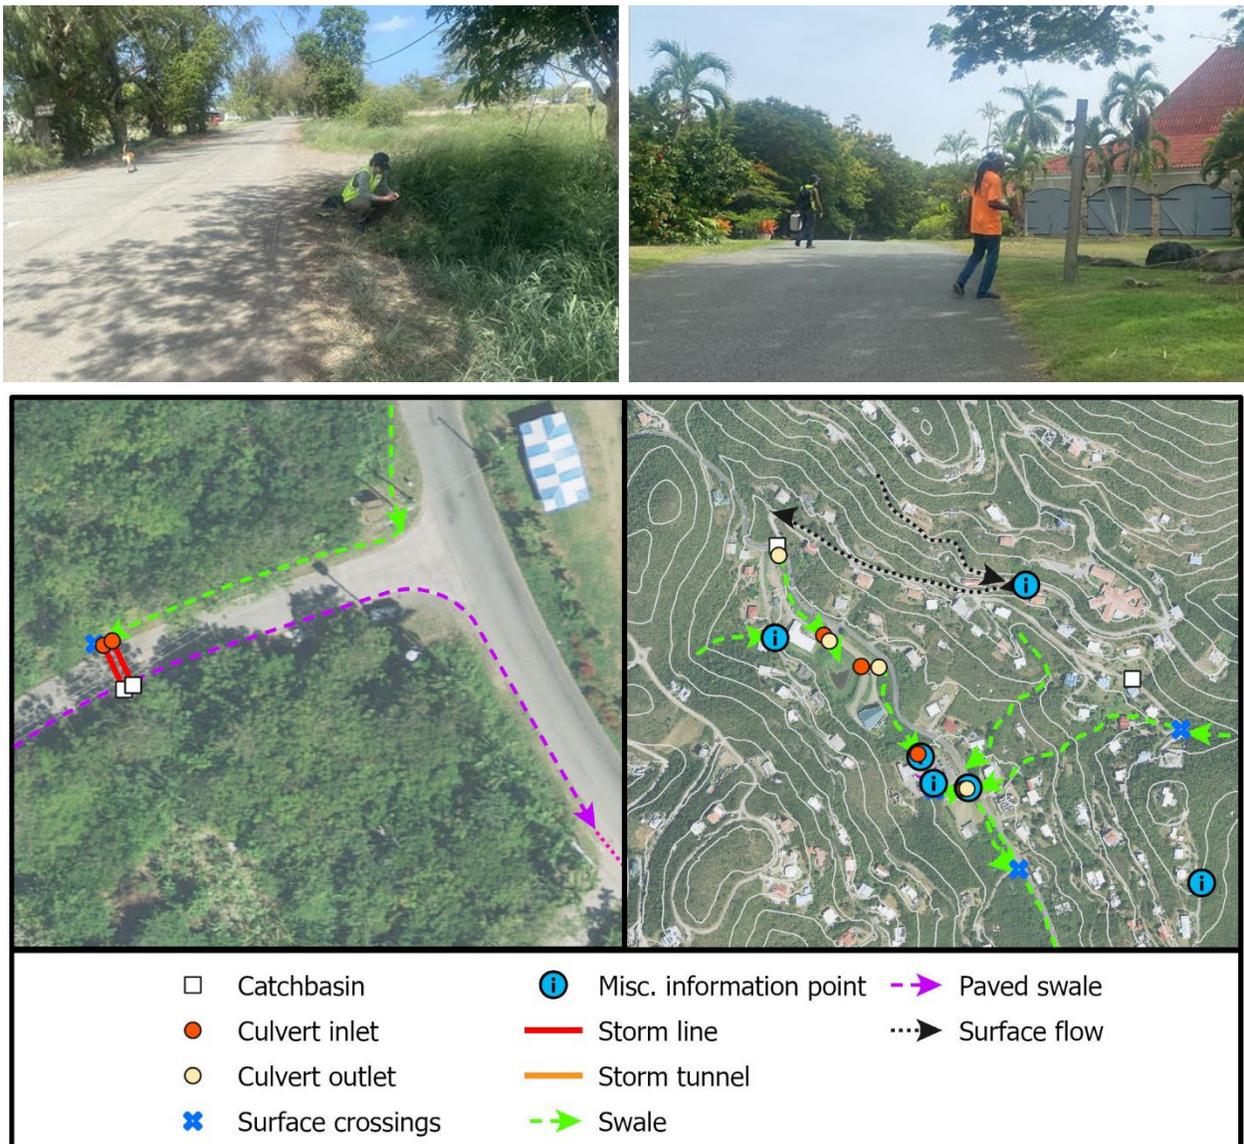
Figure 45. Inspection of existing stormwater infrastructure during field assessments (above) and an example of the maps produced (below).

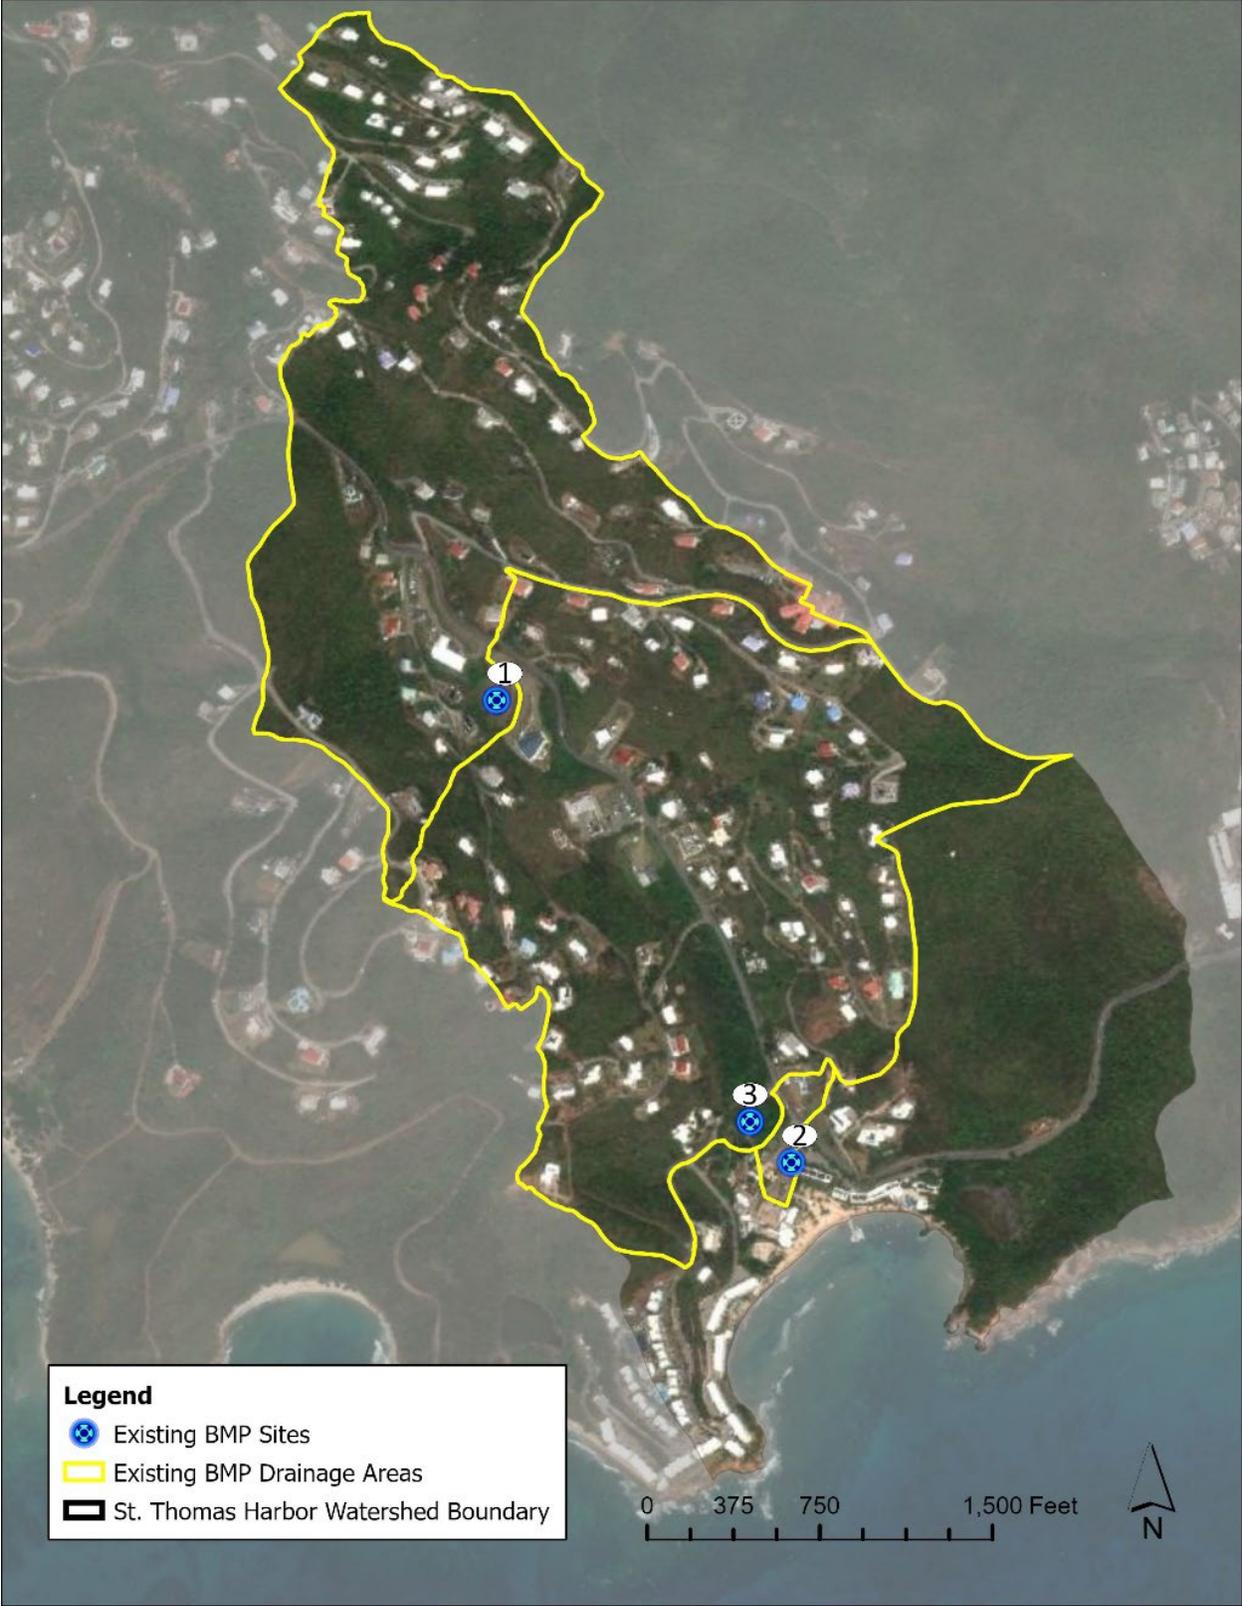
Figure 46. Existing BMPs identified within the watershed.

Existing Practice ID	BMP Type
1	Basin
2	Bioretention
3	Bioretention

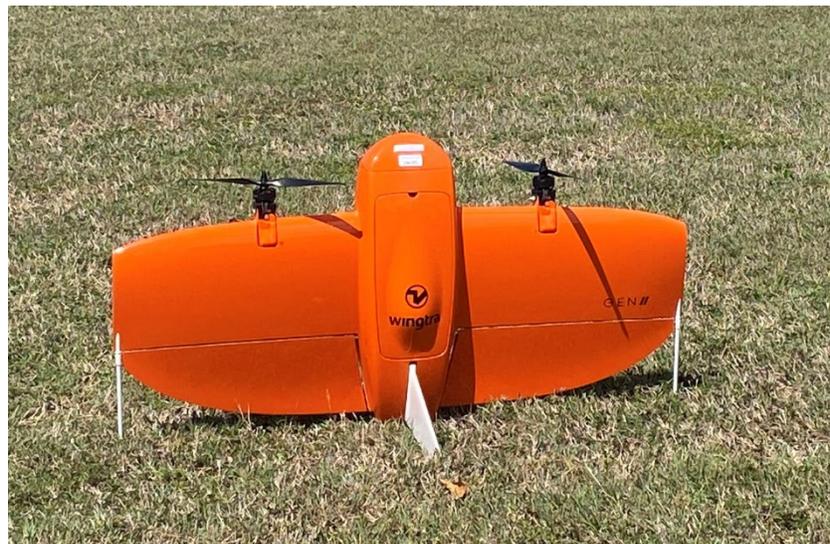
Figure 48. WingtraOne Gen II UAS utilized to collect data in the study watersheds.
