**WATERSHED
MANAGEMENT PLAN
FOR THE BOLONGO
BAY WATERSHED
ST. THOMAS, USVI**

JUNE 2022

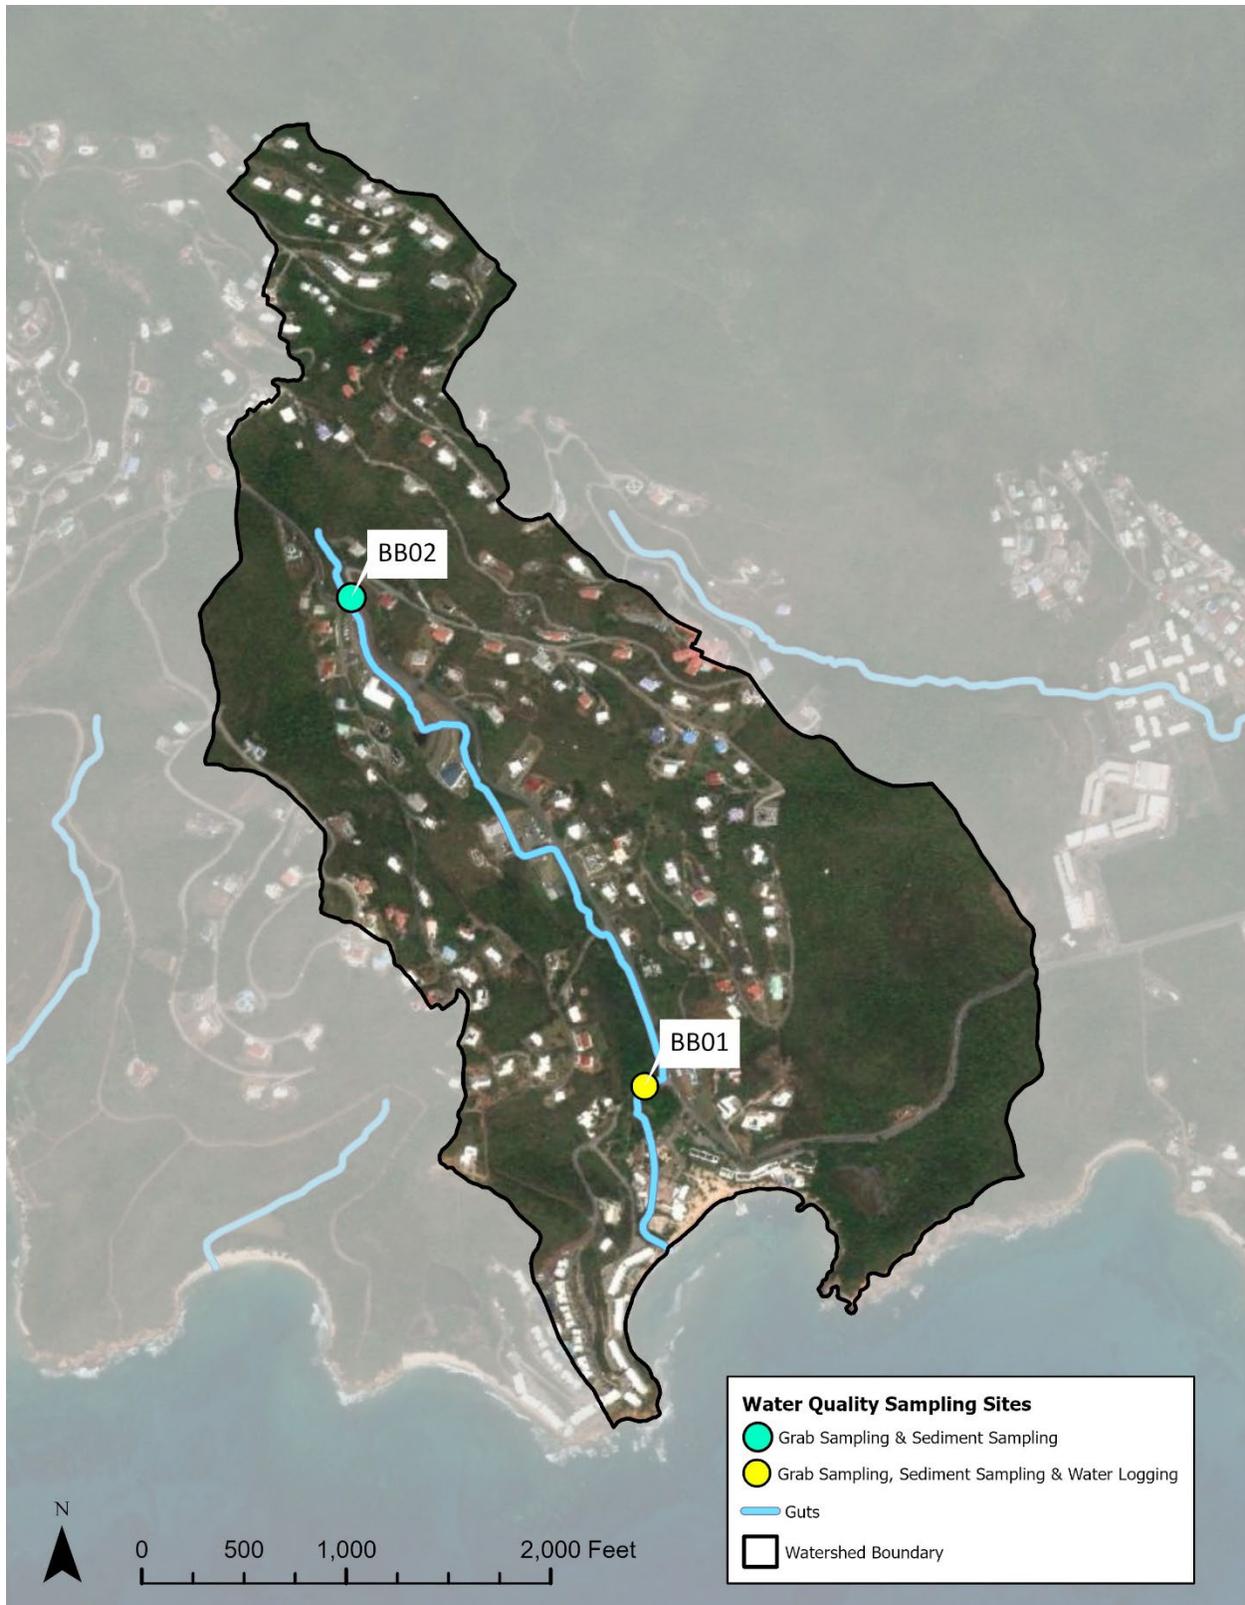
Figure 50. Grab sampling, sediment sampling, and water logging locations.

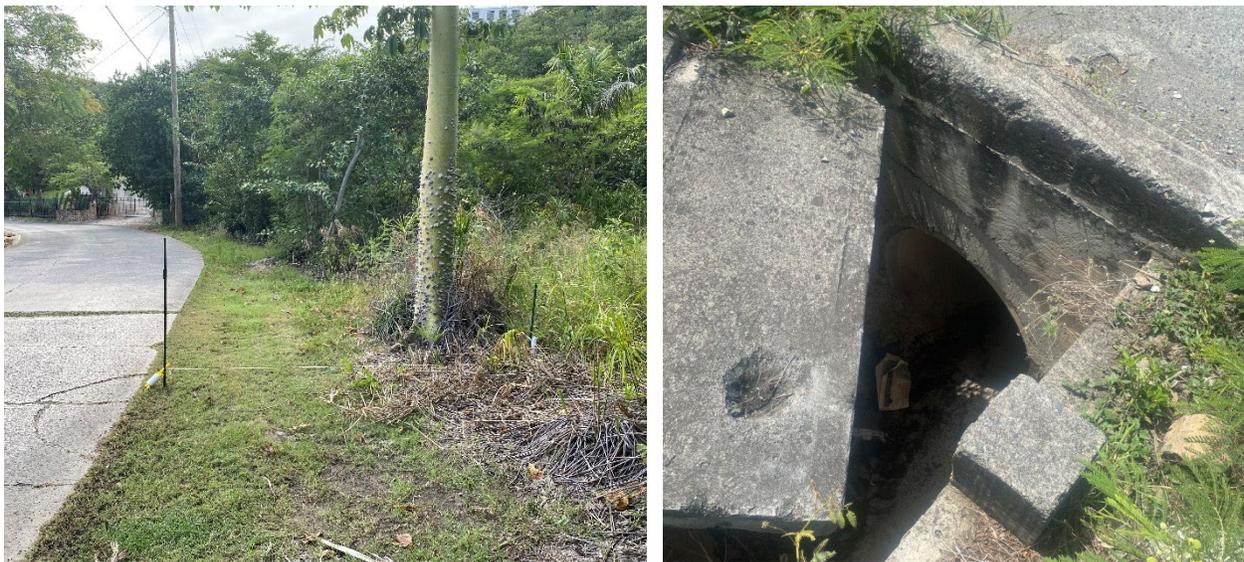
Figure 53. Grab sampling locations BB01 (left) and BB02 (right).

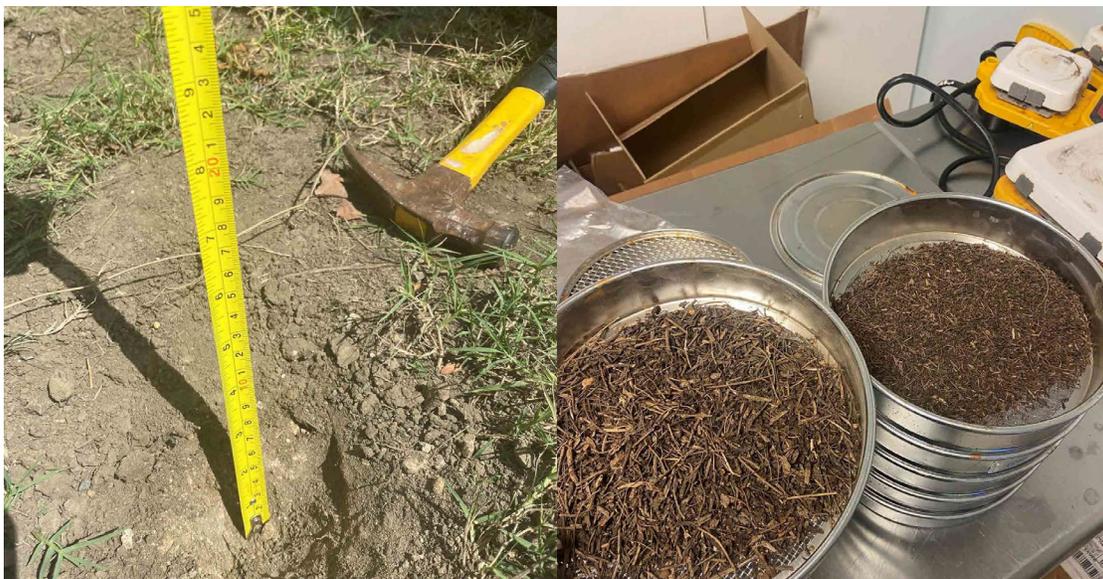
Figure 55. Field crew member measuring the depth of deposition (left) and separating a subsample of the various sediment types across the cross-section of the gut channel (right).

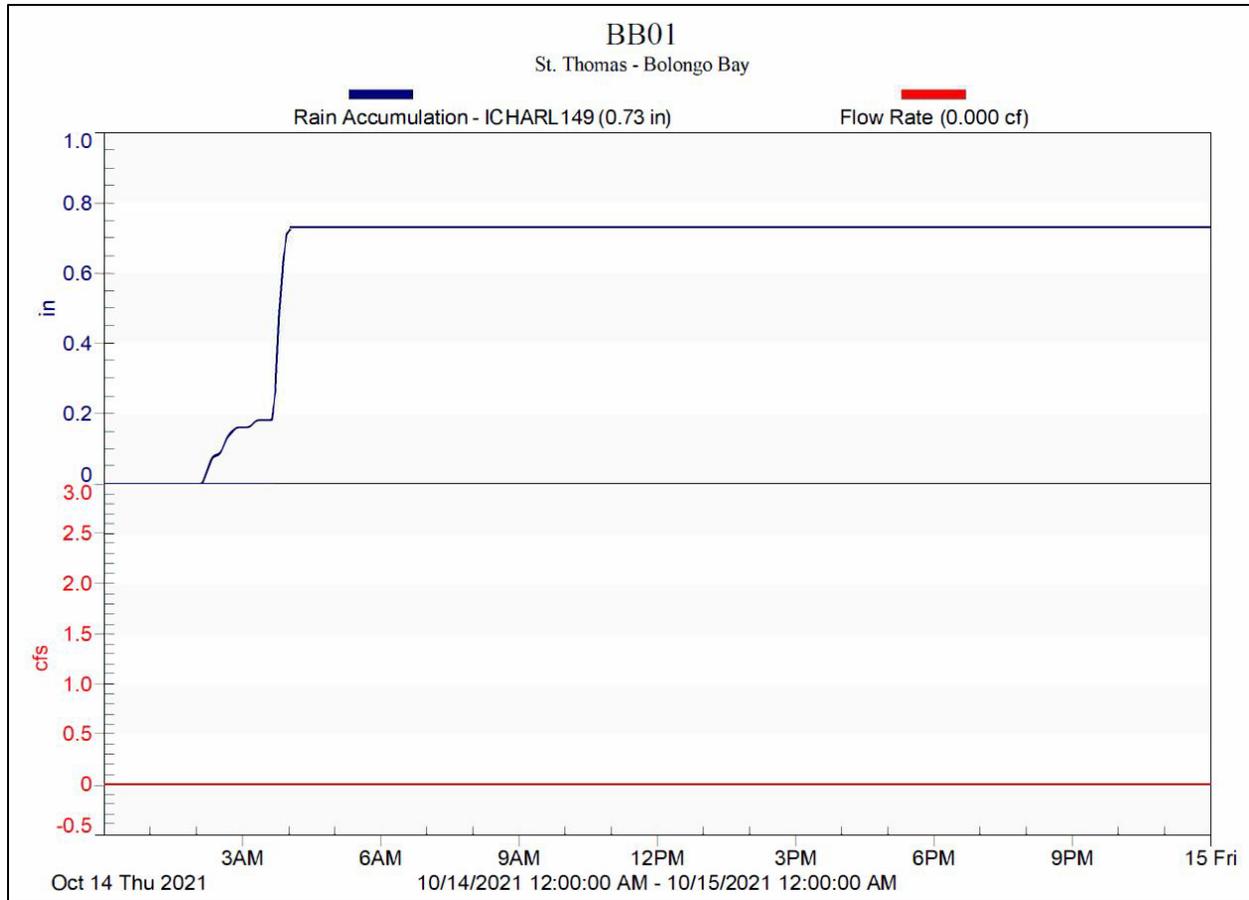
Figure 56. A hydrograph displaying the lack of flow at the BB01 gut monitoring site (0.0 cfs) in red and the corresponding rain accumulation for the storm event (0.73 in.) in blue that occurred on October 14th, 2021.

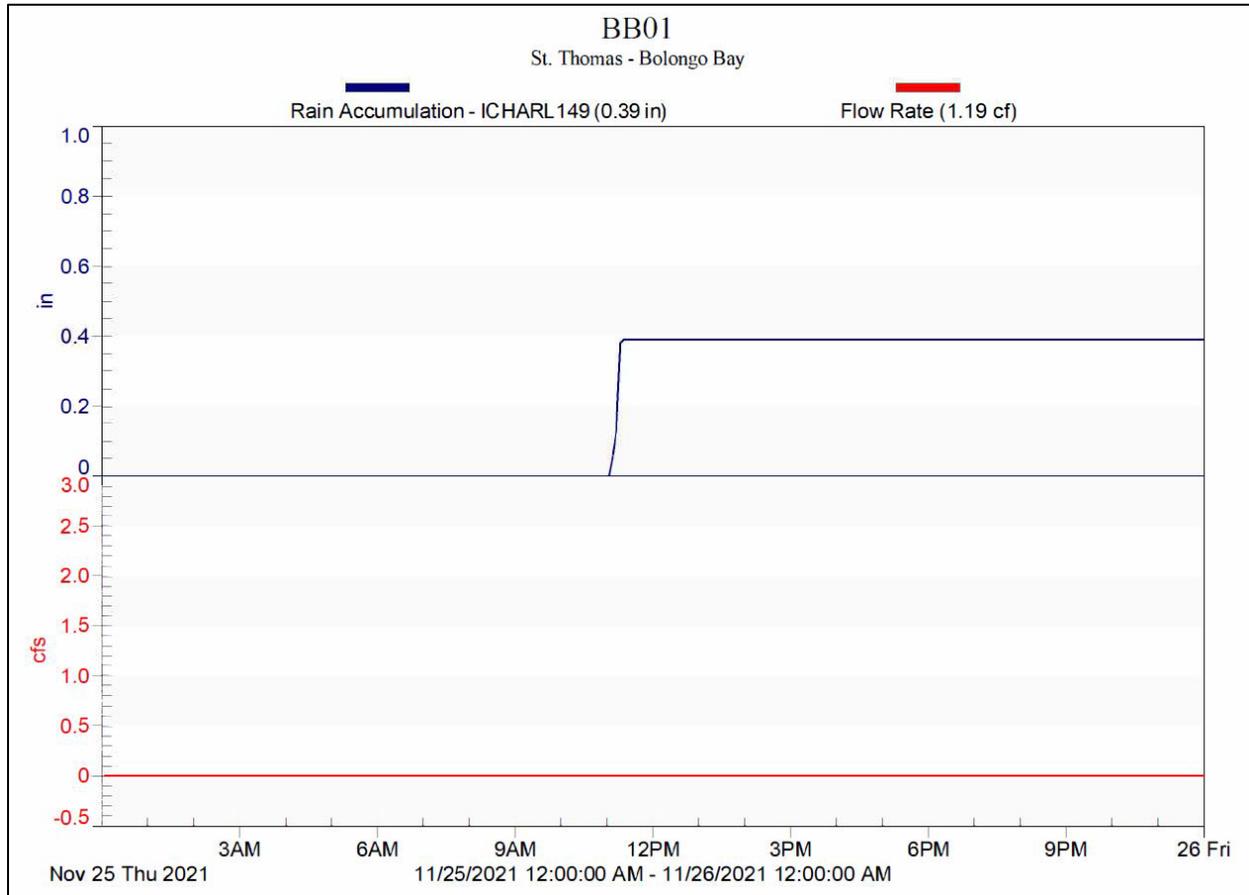
Figure 57. A hydrograph displaying the lack of flow at the BB01 gut monitoring site (0.0 cfs) in red and the corresponding rain accumulation for the storm event (0.39 in.) in blue that occurred on November 25th, 2021.

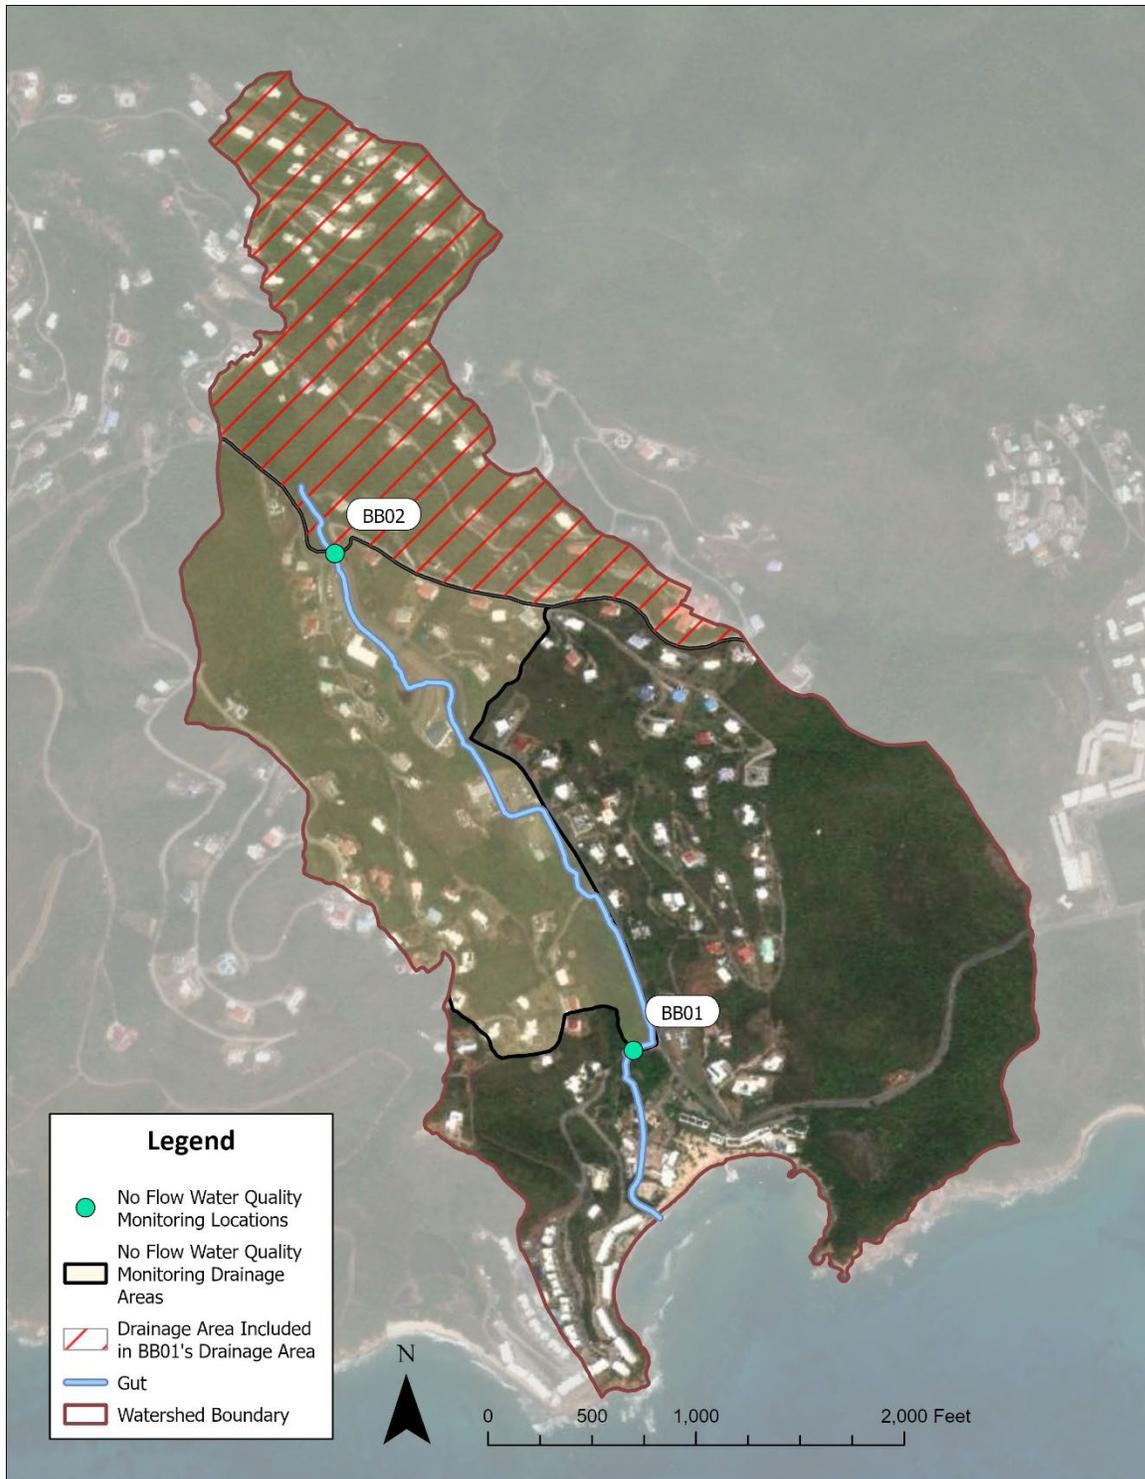
Figure 59. The BB01 and BB02 monitoring locations were confirmed to have no storm flow during five qualifying rain events between October and December of 2021. The BB01 drainage area is delineated in light yellow and the BB02 drainage area is shown with red diagonal lines.

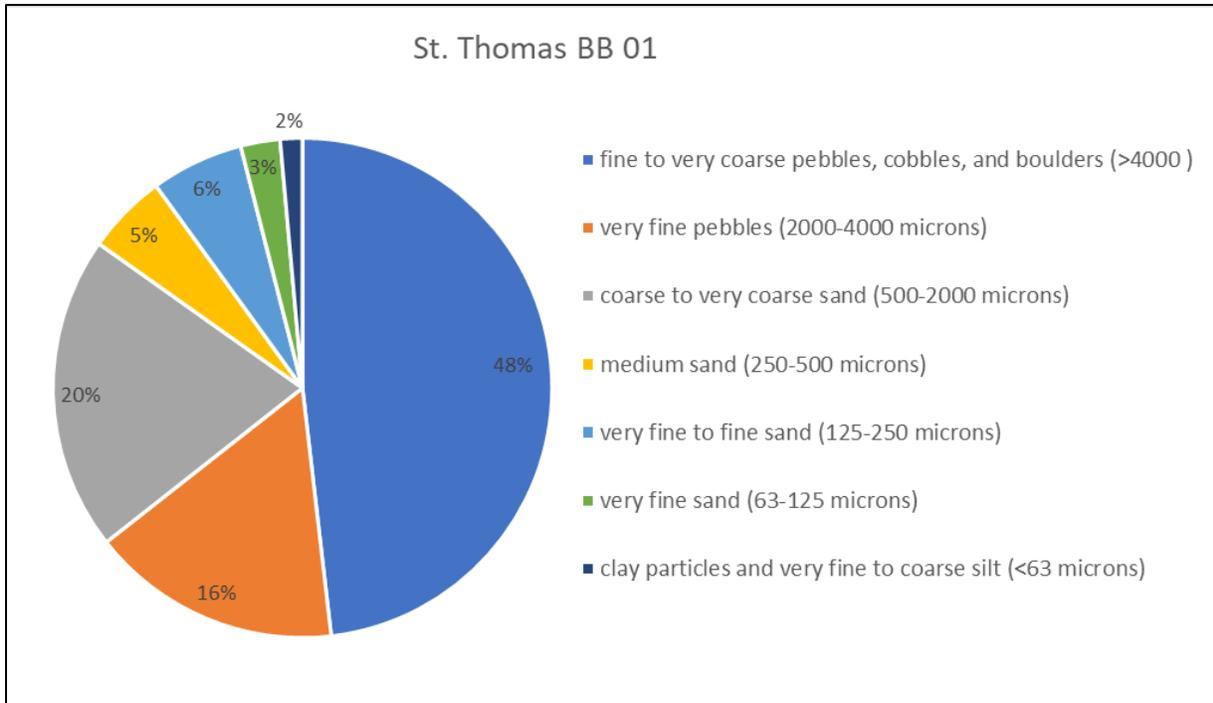
Figure 61. The percent composition of the seven grain size categories within the BB01 sediment sample.

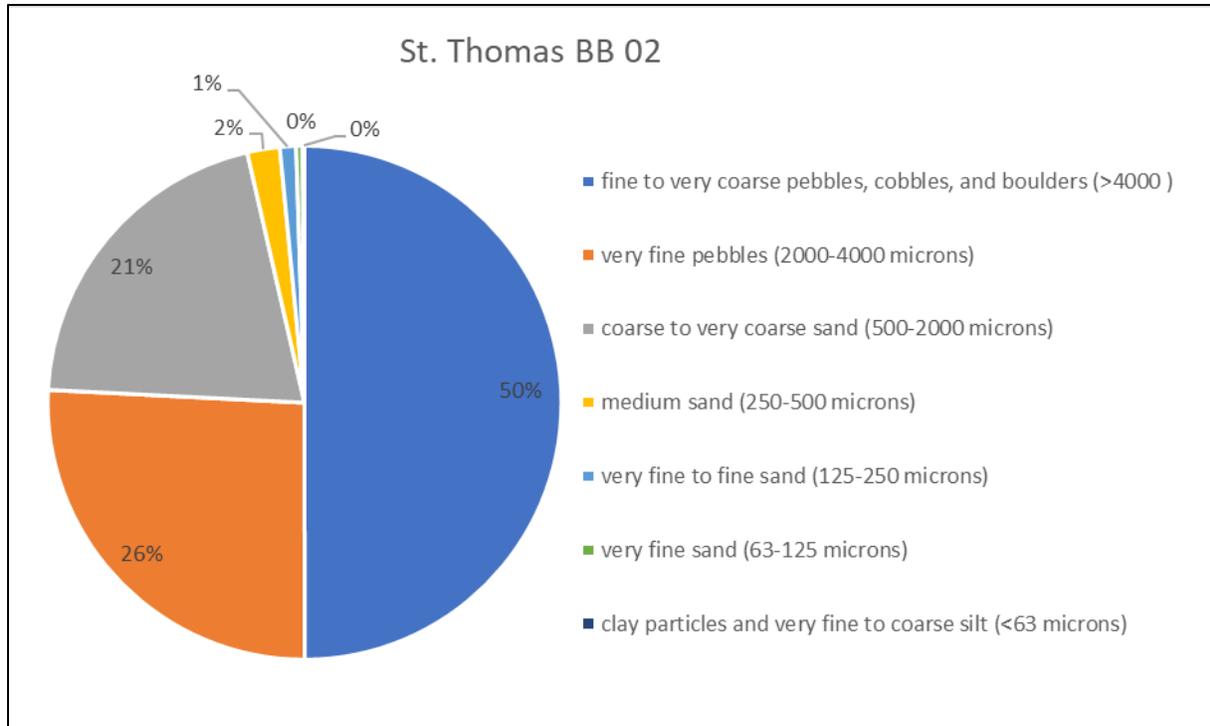
Figure 62. The percent composition of the seven grain size categories within the BB02 sediment sample.

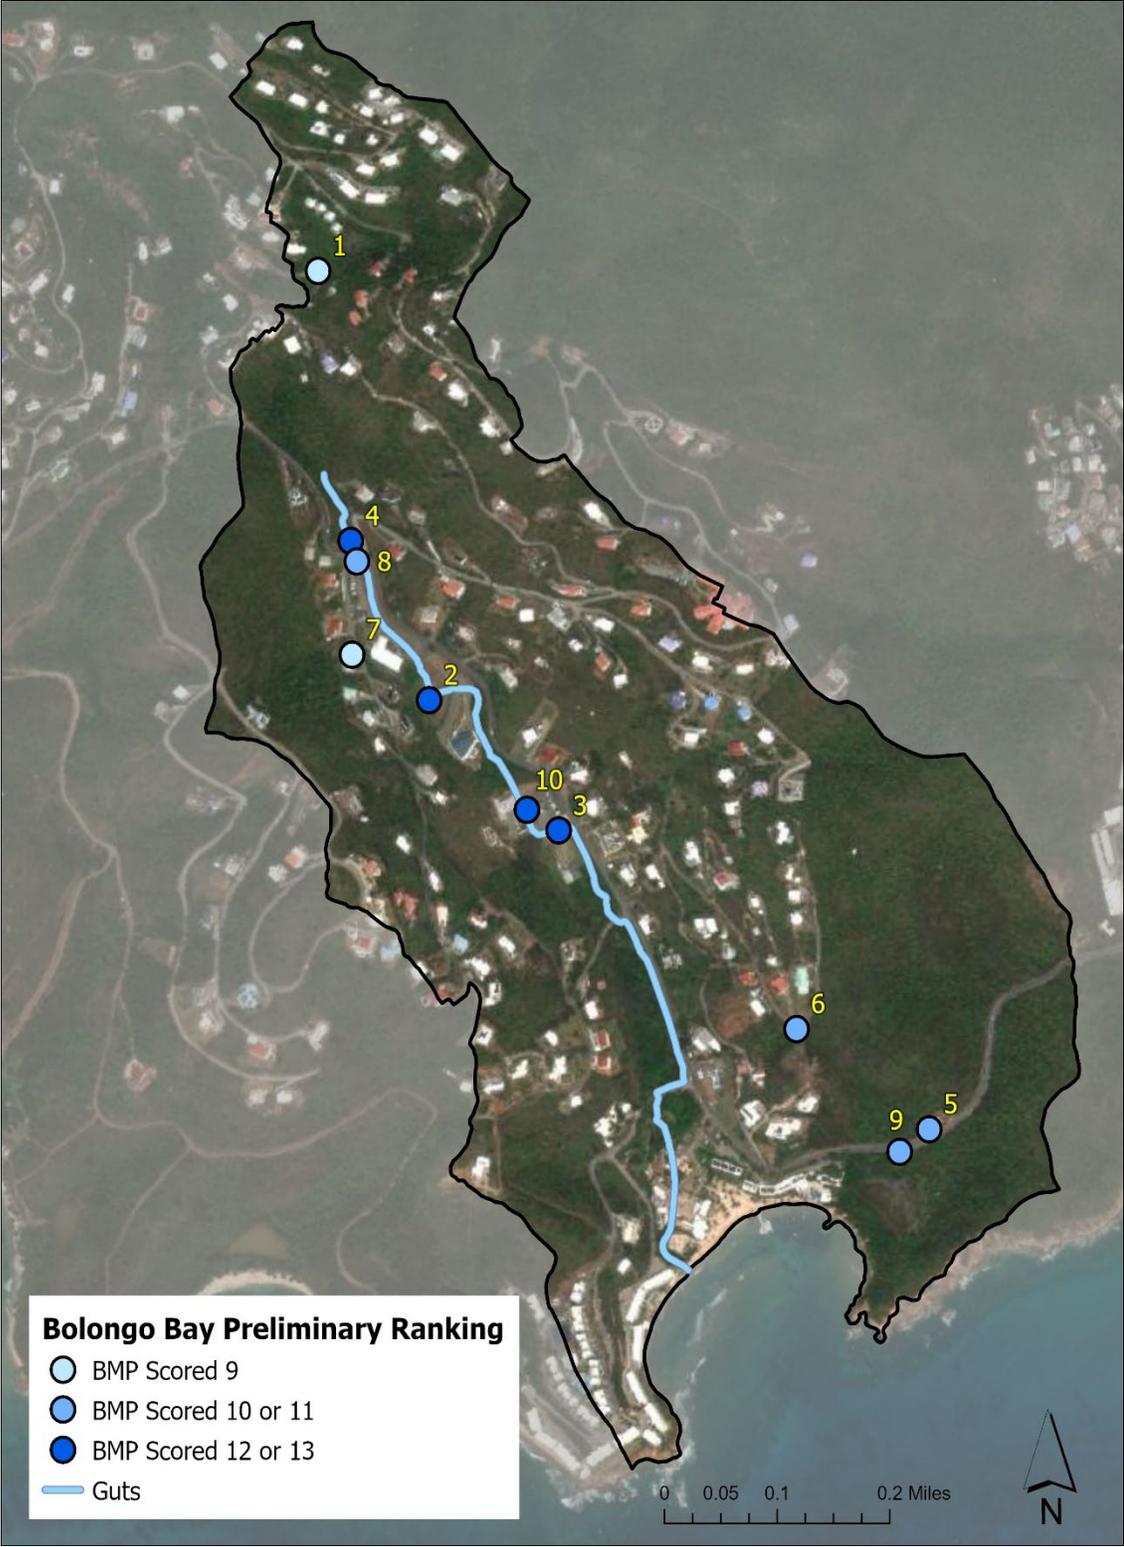
Figure 66. Map of proposed BMP points and preliminary ranking results.

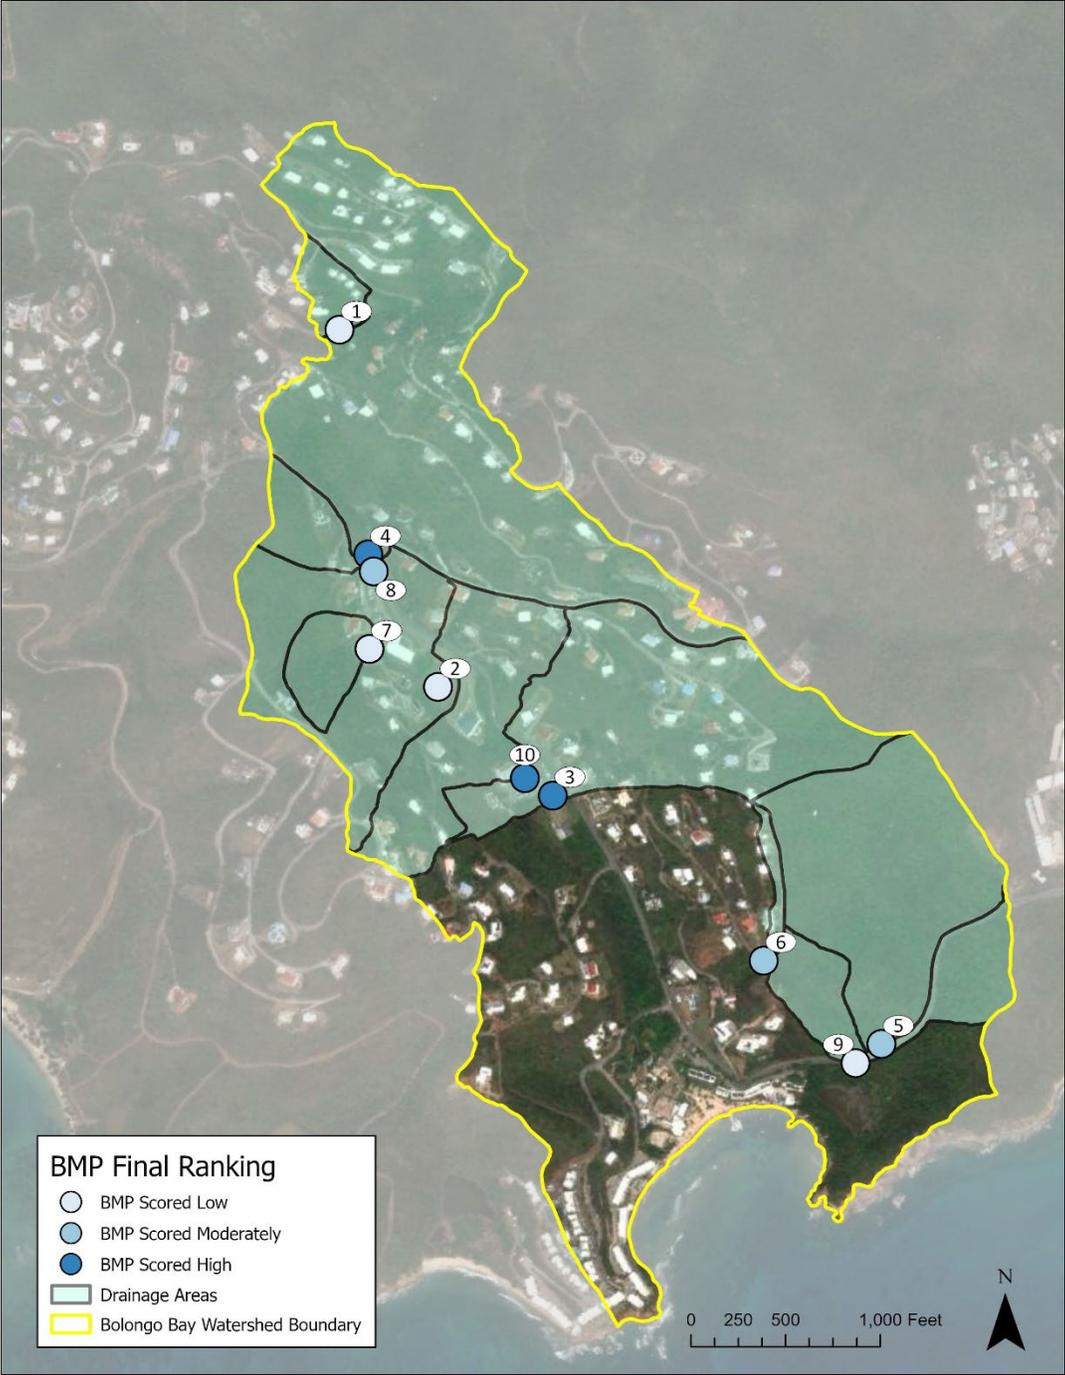
Figure 67. The relative ranking of each BMP and the associated BMP drainage areas. Note that drainage areas for BMPs often overlap.

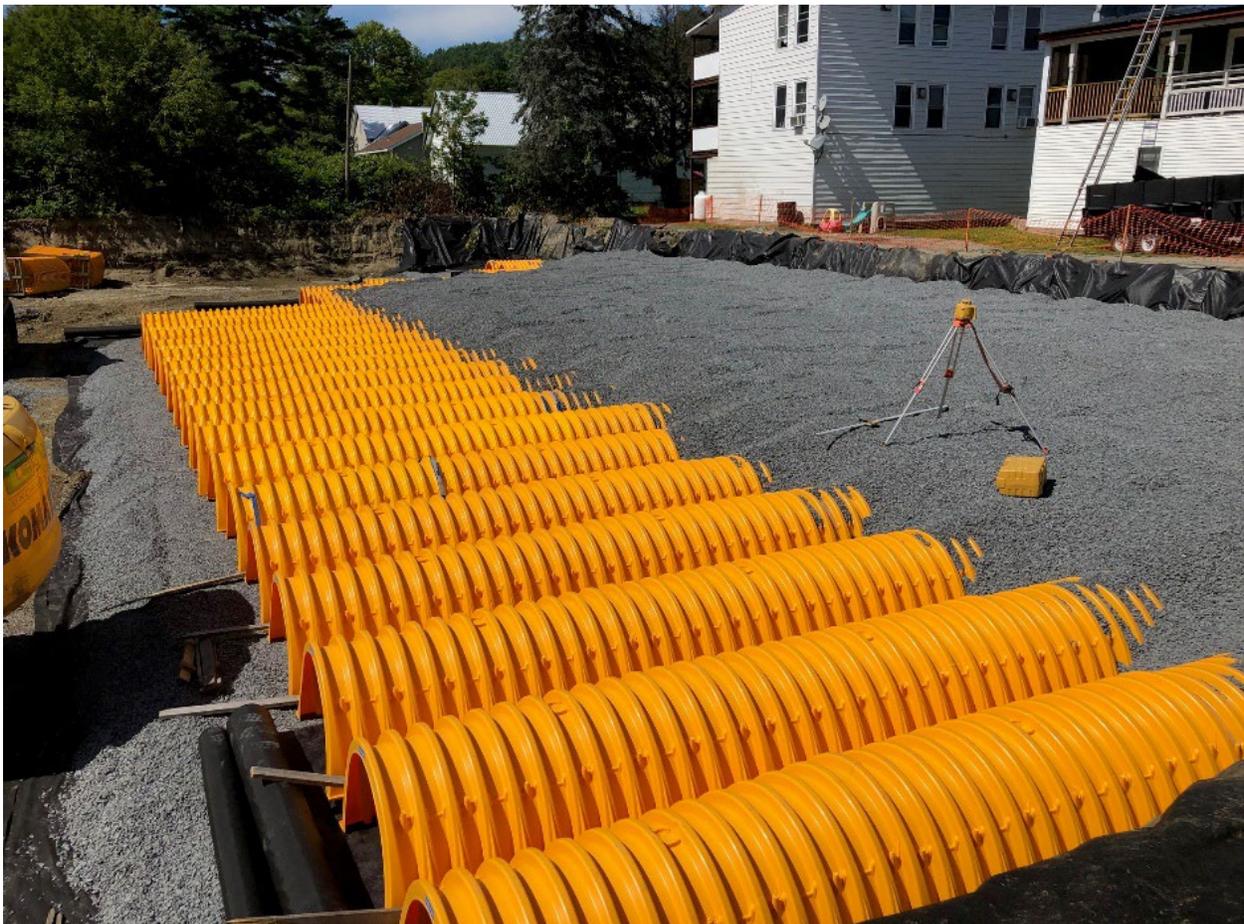
Figure 68. Example photo of subsurface infiltration chambers.

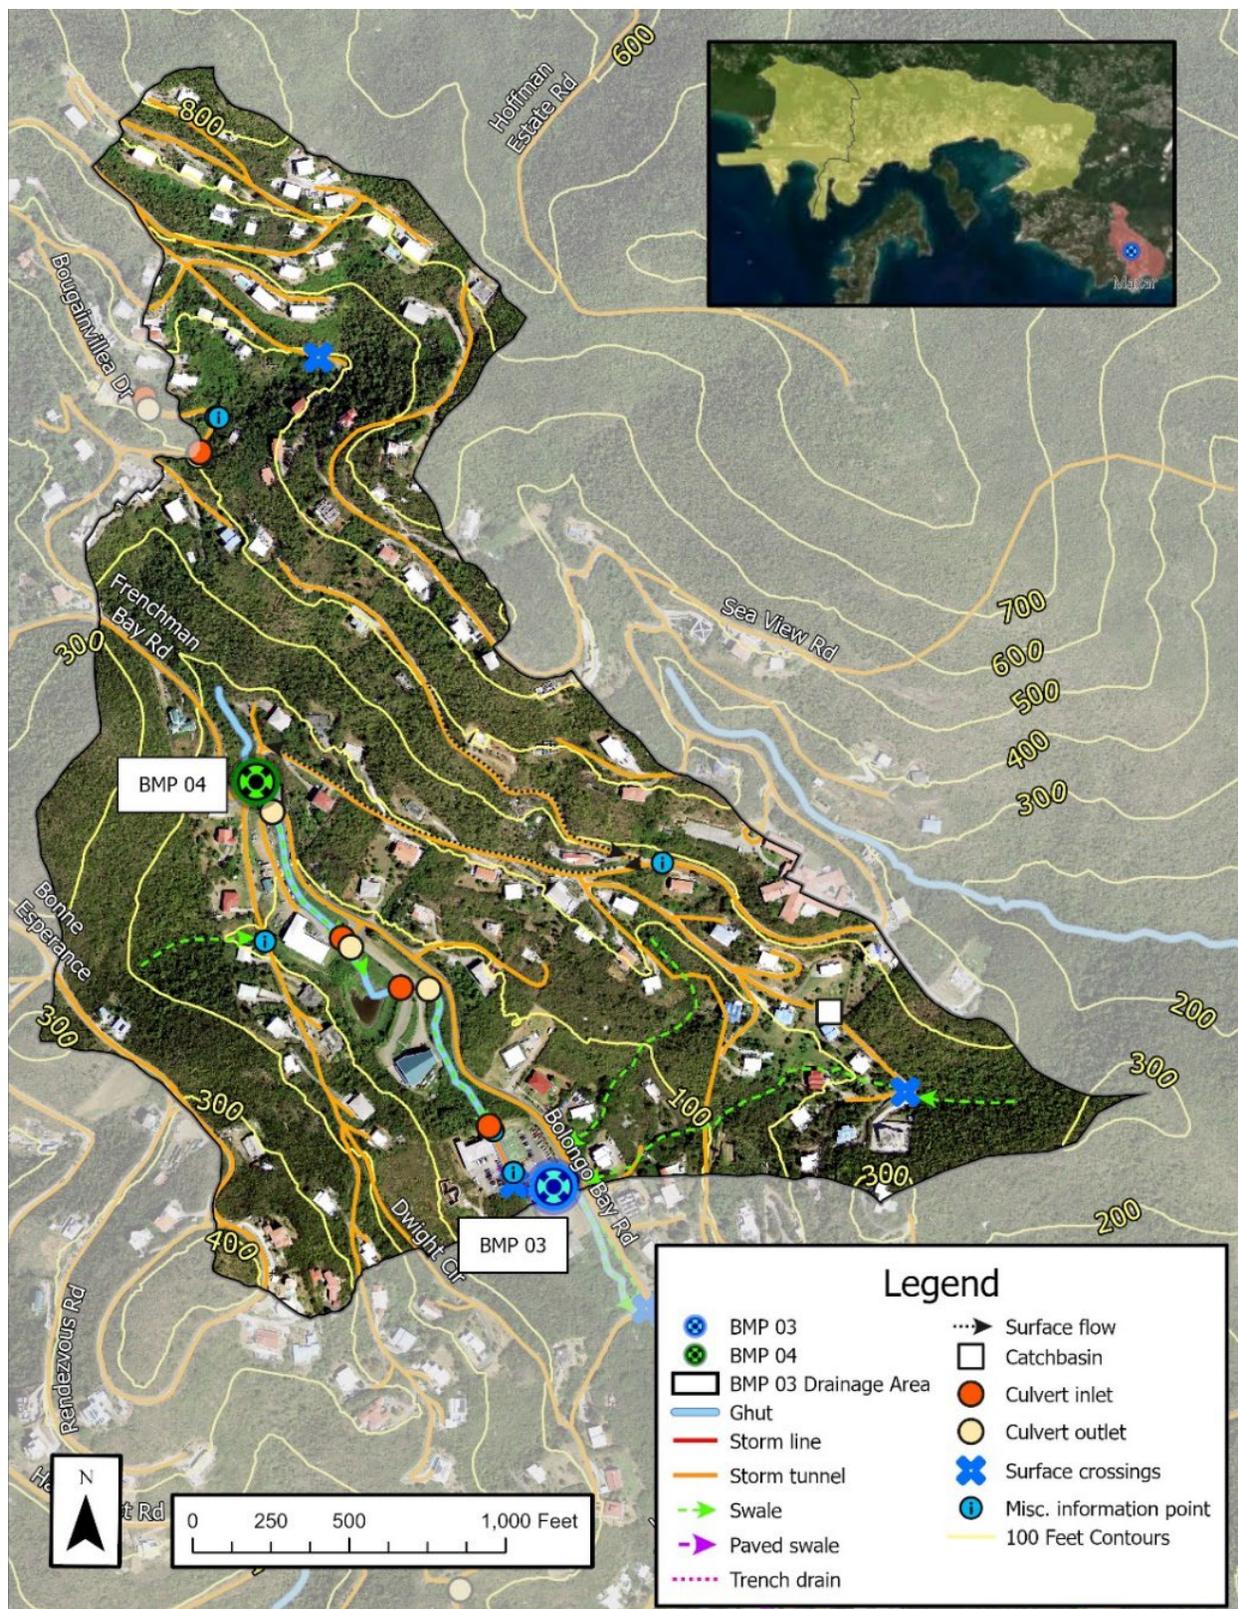
Figure 69. Drainage area to BMP 03.

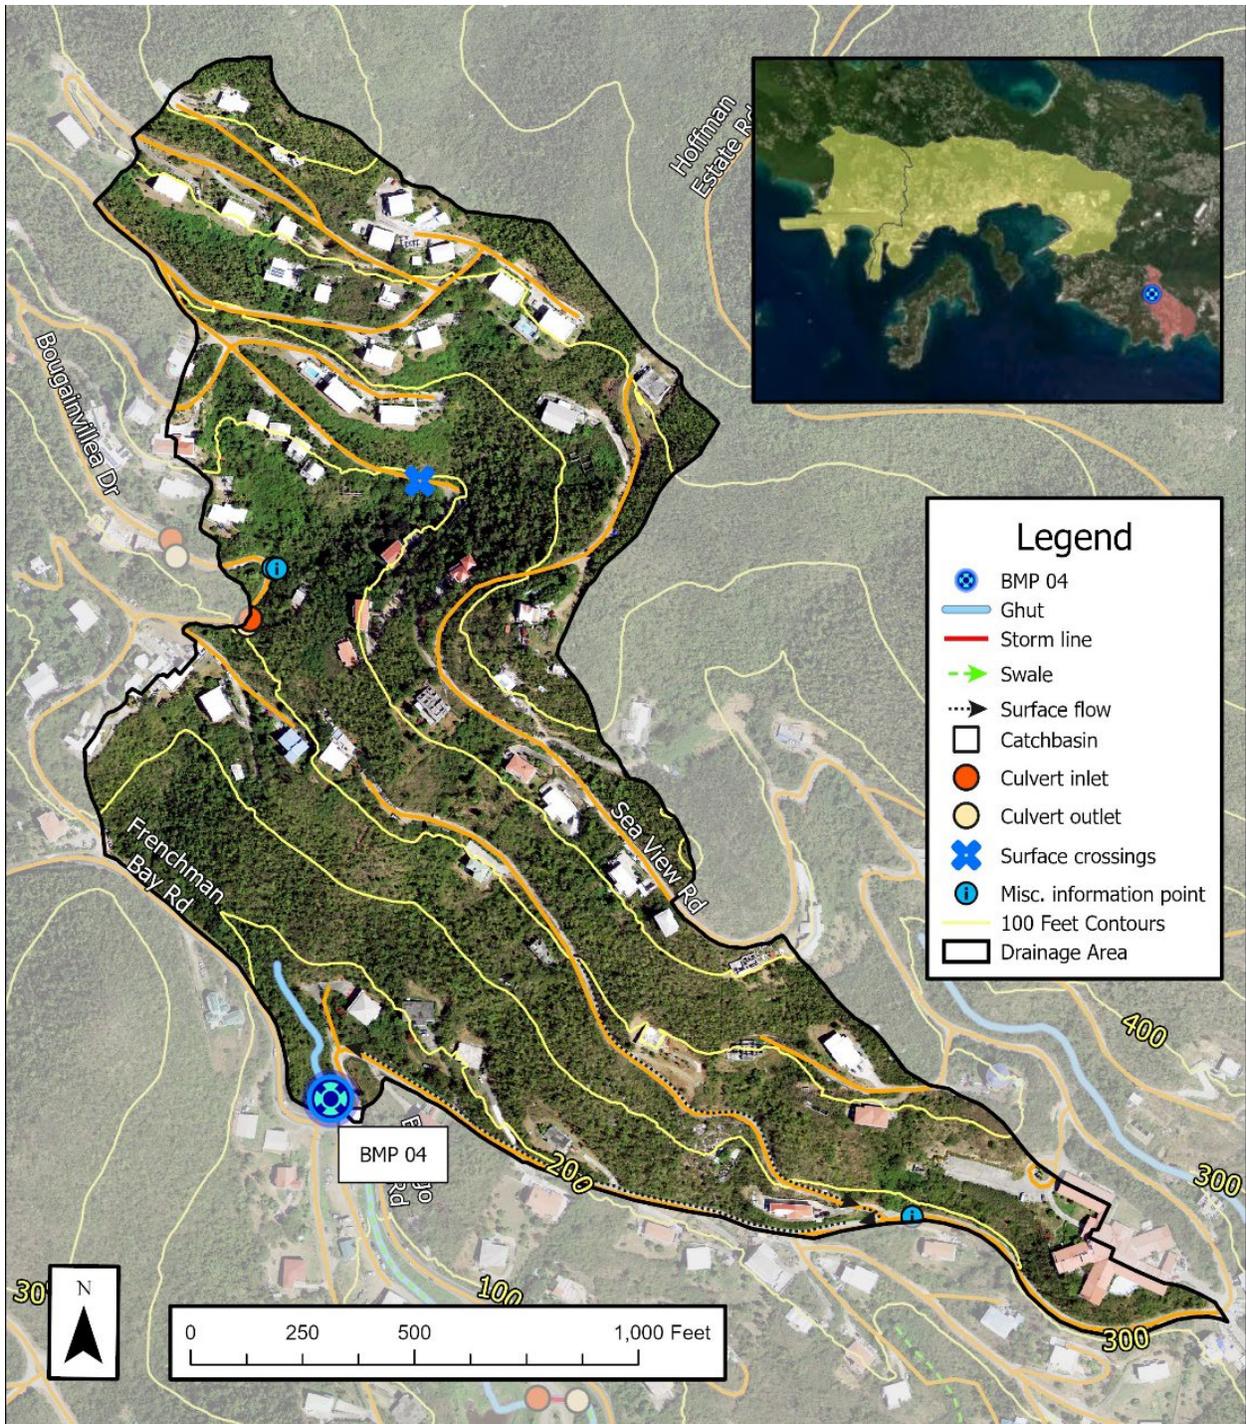
Figure 71. Drainage area to BMP 04.

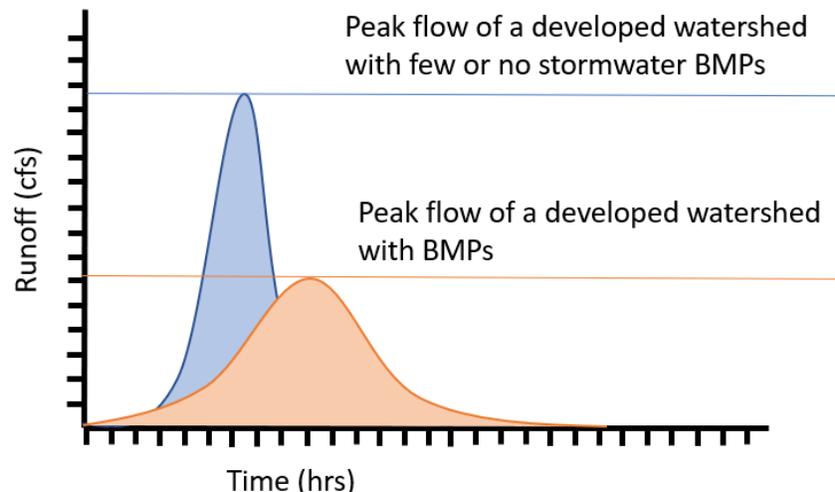
Figure 72. Illustrative hydrographs demonstrating the peak flow reduction value of implementing BMPs.

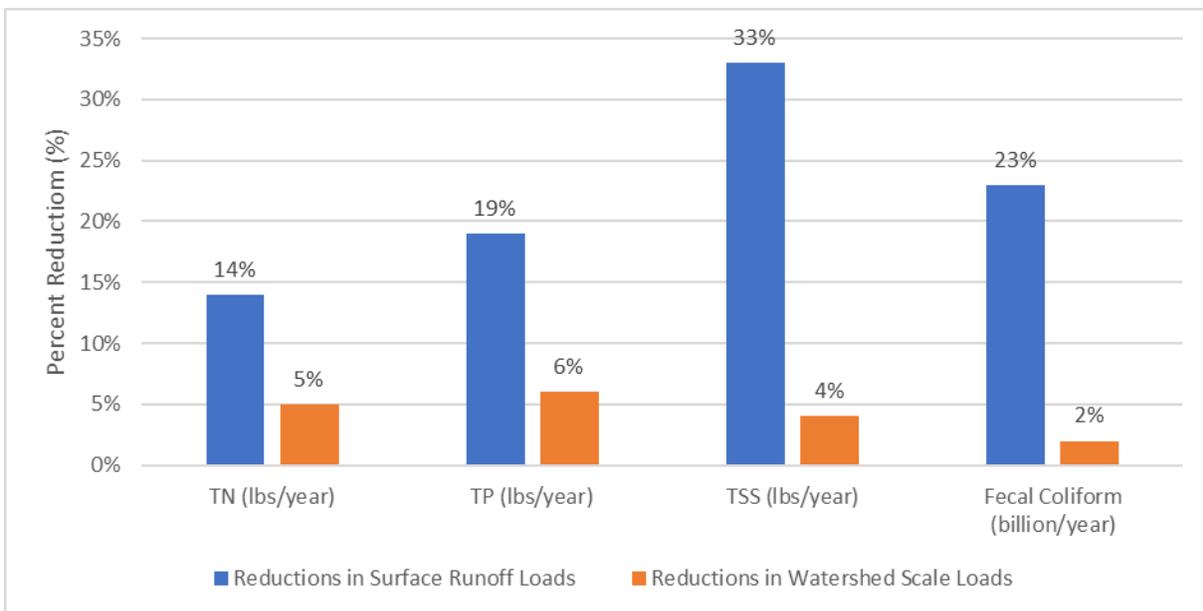
Figure 74. Pollutant load reductions attributable to the Top 10 BMPs for the Surface Runoff category (blue) and for all modeled watershed sources (orange).
